Gambit Inspections Ltd.

Your property inspection report

90210 Electric Ave

Inspection prepared for: John & Jane Doe

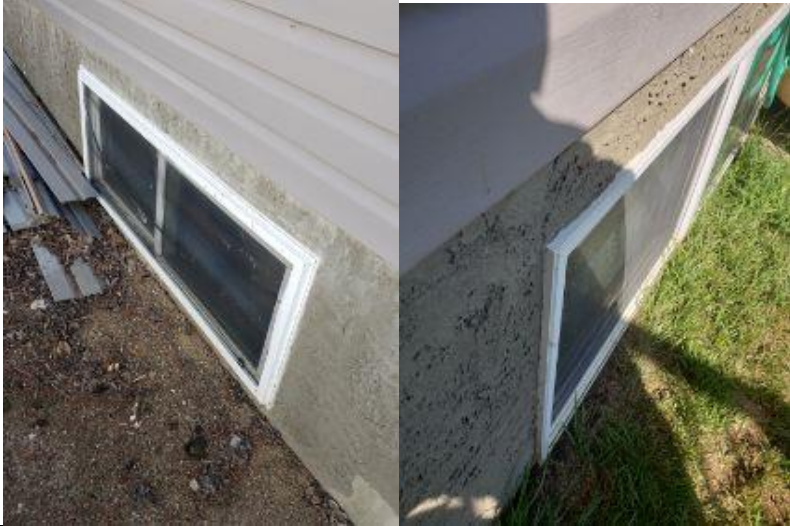
Summary of Items		
1. Exterior		
1.8	Windows & Doors	<ul style="list-style-type: none">• 2 exterior windows were very close to grade. Would recommend window wells be installed to prevent water entry.

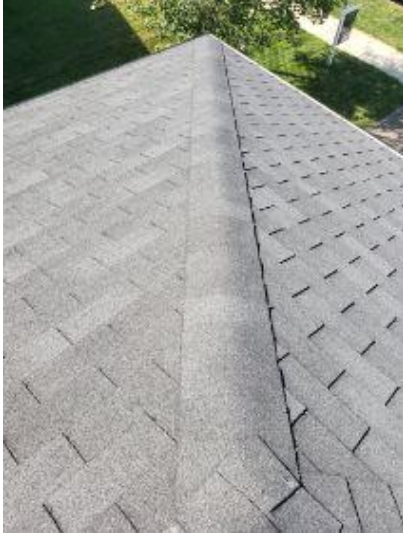
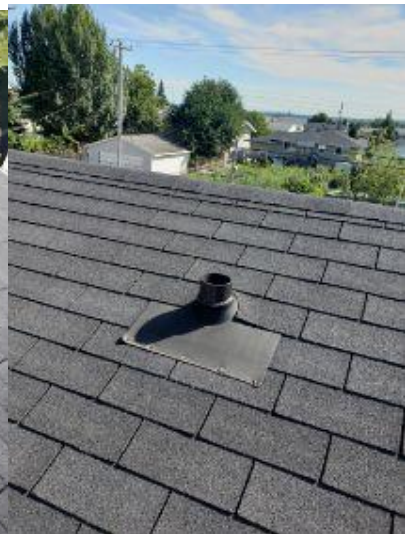
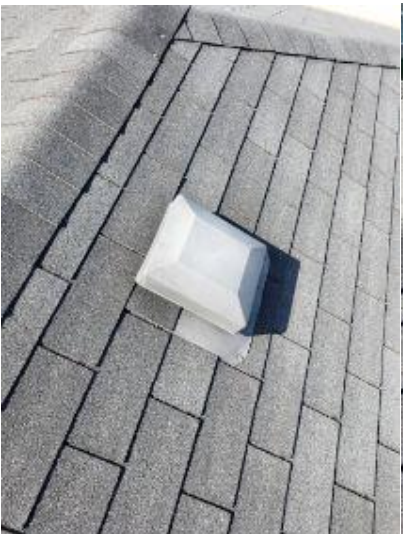
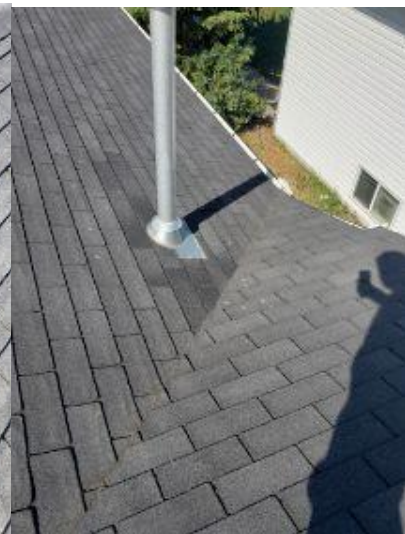
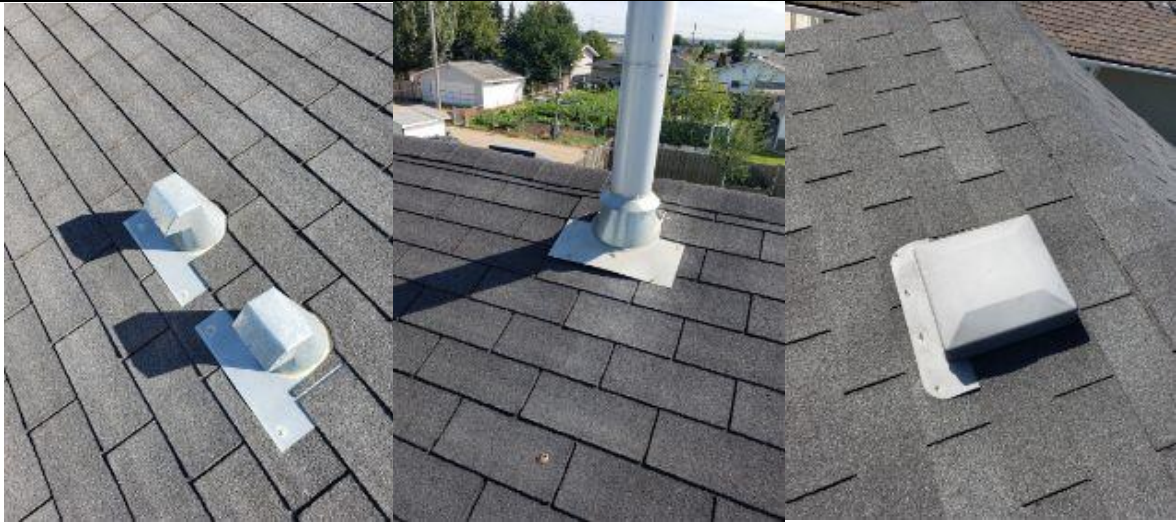
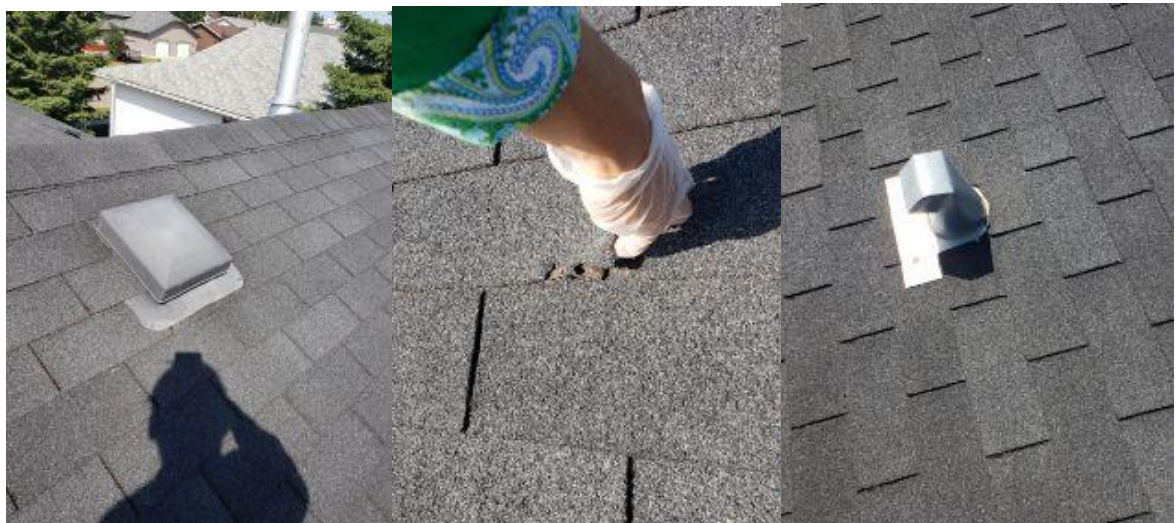
1.1 Roof

Materials	3-Tab asphalt shingles, life expectancy 20 years from installation with proper maintenance.	<ul style="list-style-type: none">• No major system safety or function concerns noted at time of inspection. Normal aged.• Flashings installed, no loose nails observed during inspection. Would recommend adding roofing tar to nails that are exposed.• Some loose shingles noticed but no excessive cupping or curling was observed.
-----------	---	---

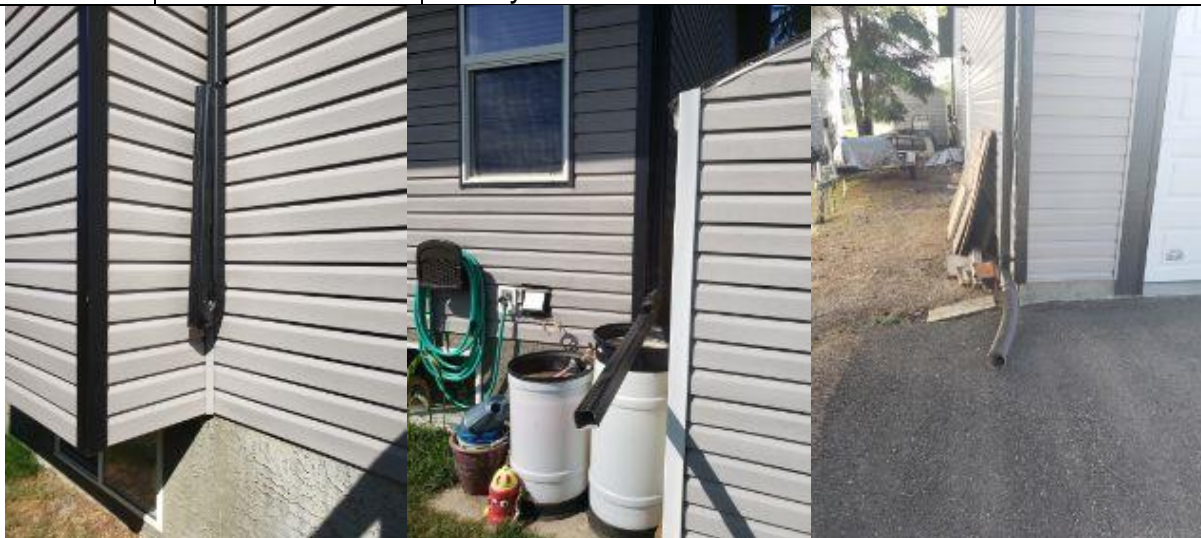
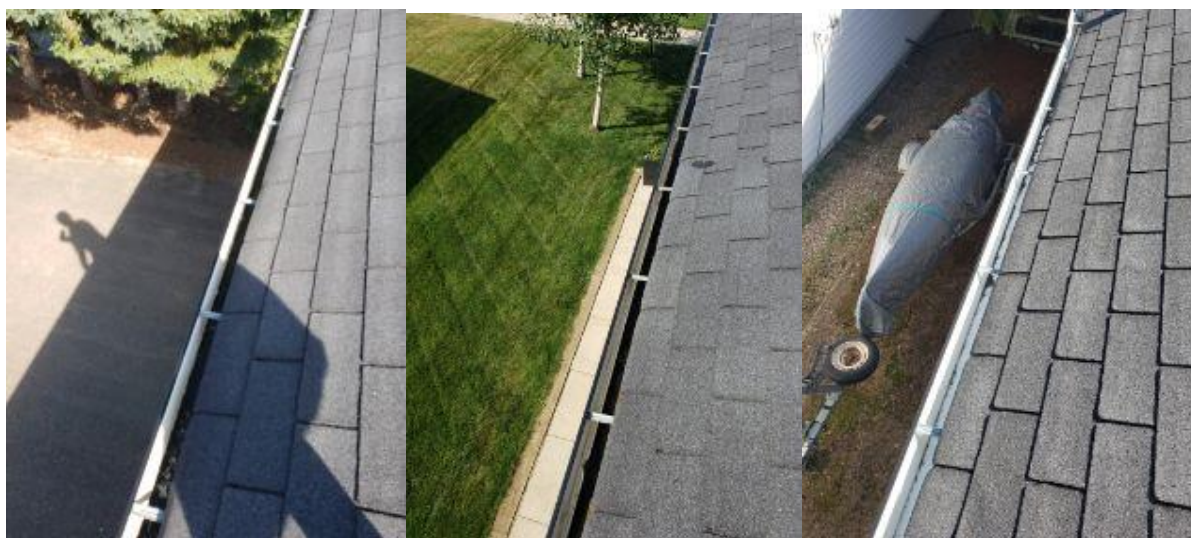
1.2 Gutters and Grading

<ul style="list-style-type: none"> • One downspout was raised during the inspection, would recommend this be lowered during rain. All others drained away from the foundation • Maintenance tip: re-grading due to settlement every 7-10 years recommended.
--	--	---

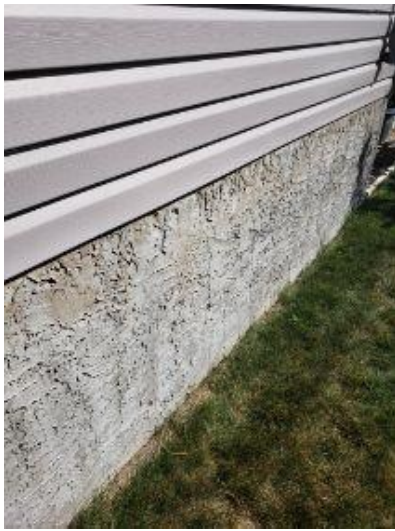
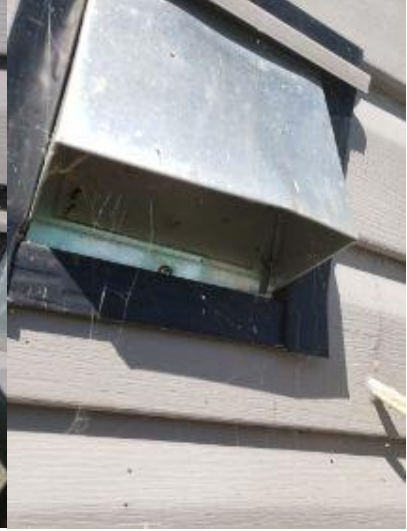
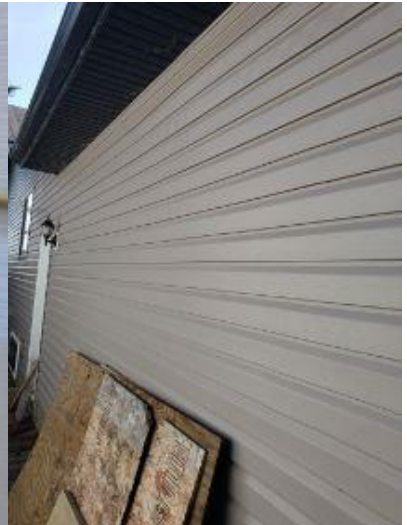
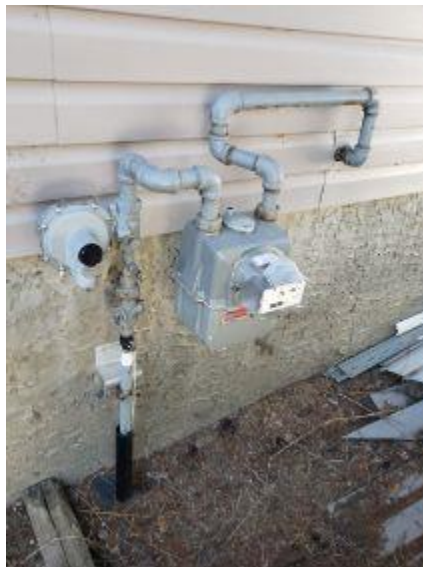
1.4 Facade

Materials	Vinyl, wood frame construction, concrete foundation	<ul style="list-style-type: none"> • No major system safety or function concerns noted at time of inspection. • Clean furnace + dryer air intake cover yearly. • Recommend caulking and sealing all gaps, cracks and openings. • Maintenance tip: addressing parging on foundation wall every 4-5 years recommended to prevent water intrusion in foundation cracks
-----------	---	---

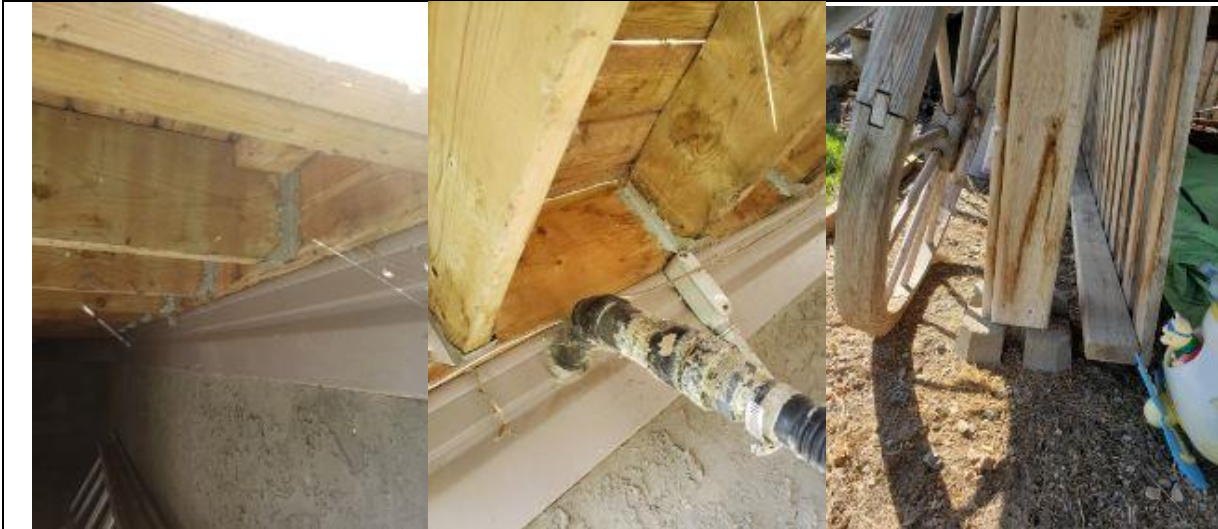
1.6 Deck and Steps	
Observations	<ul style="list-style-type: none">• No major system safety or function concerns noted at time of inspection.• Handrails felt secure with a firm shake• Proper ledger flashing, ledger brackets fasteners were filled and support columns embedded into footers

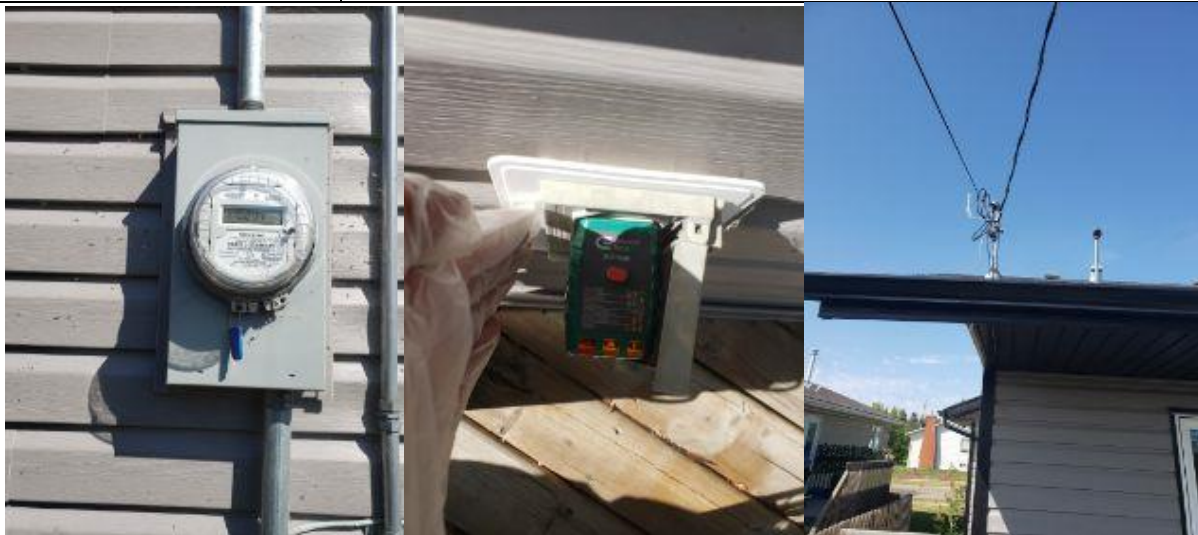
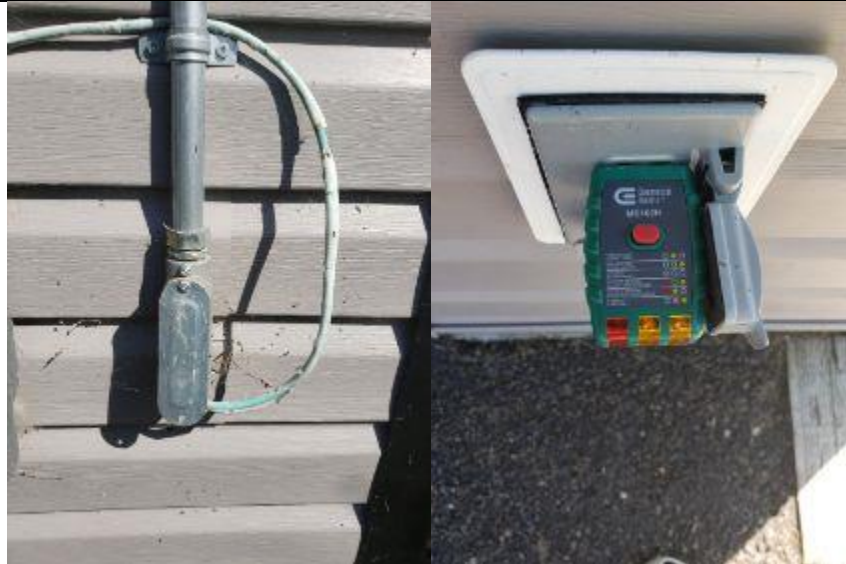
1.7 Electrical (Exterior)

- 200A meter outside
- Electrical outlets tested, no safety or functional concerns
- One loose conduit cover observed.

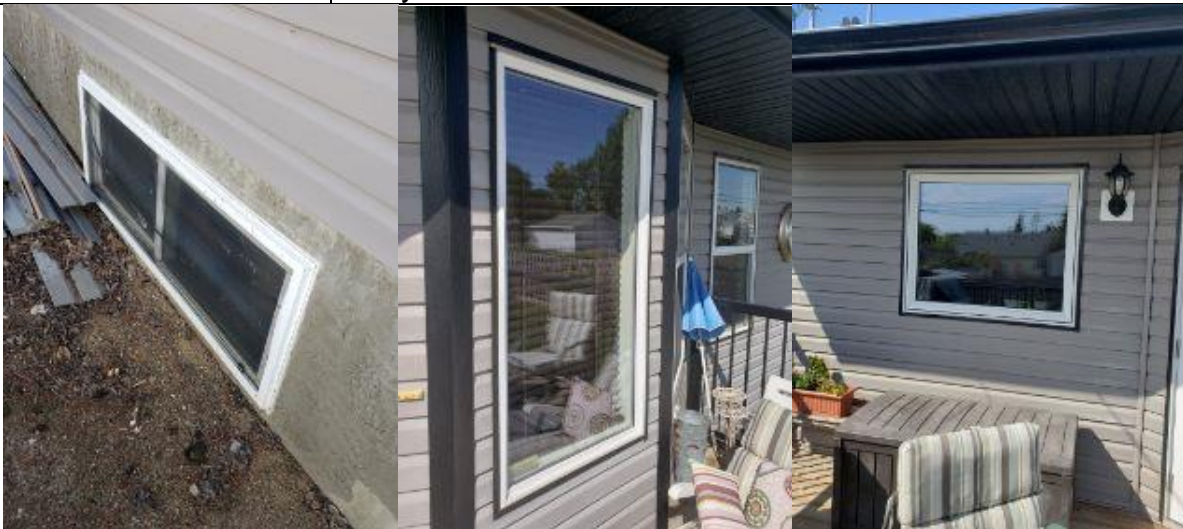
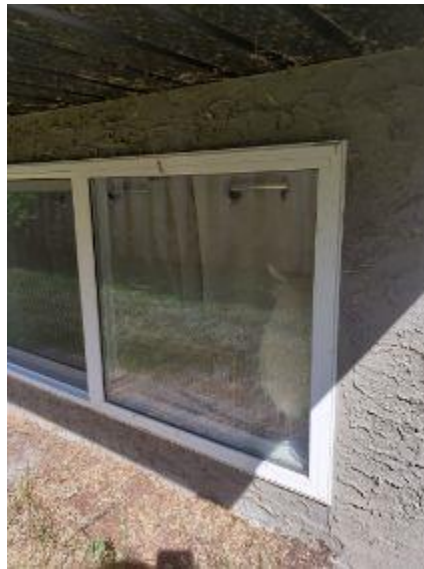
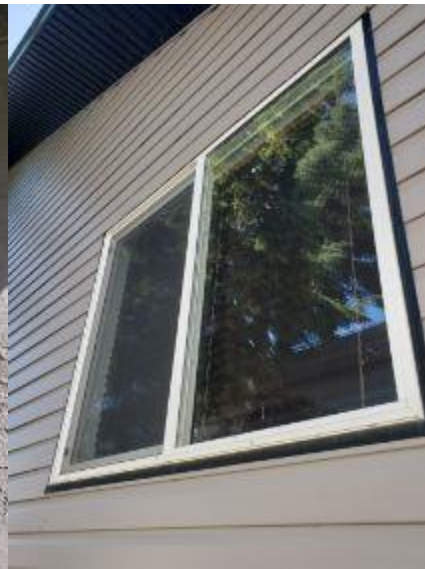
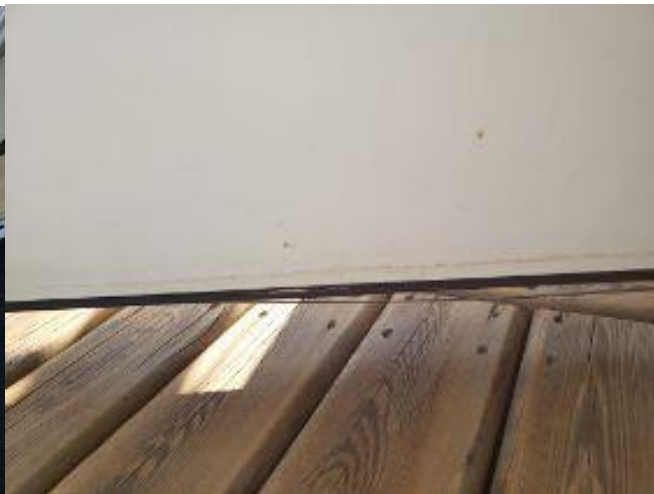
1.8 Doors and Windows

- Flashings not observed on basement windows to prevent water entry, would recommend using urethane or silicone to prevent moisture intrusion
- Exterior doors opened & closed smoothly
- Back deck door observed some air leakage on the thermal camera. Weather stripping was a bit worn.
- 2 exterior windows were very close to grade. Would recommend window wells be installed to prevent water entry.

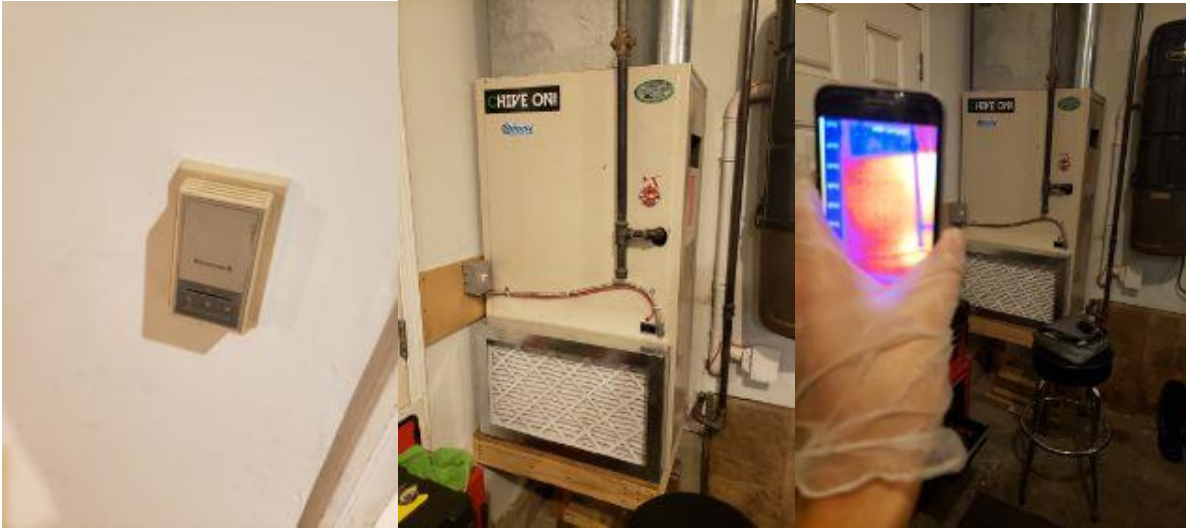
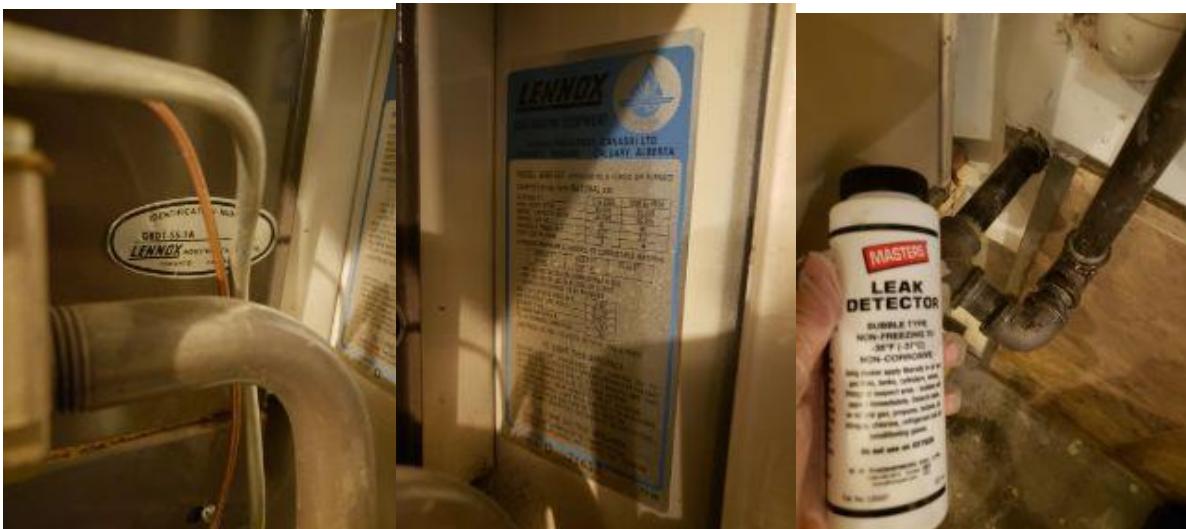
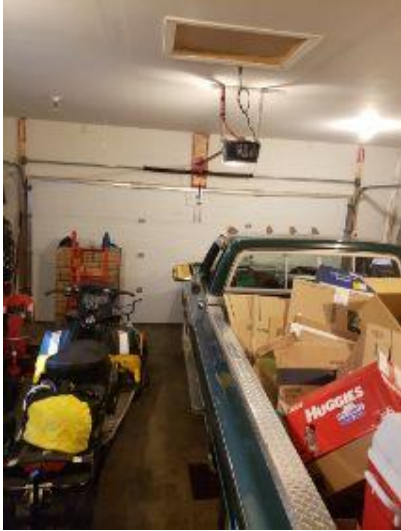
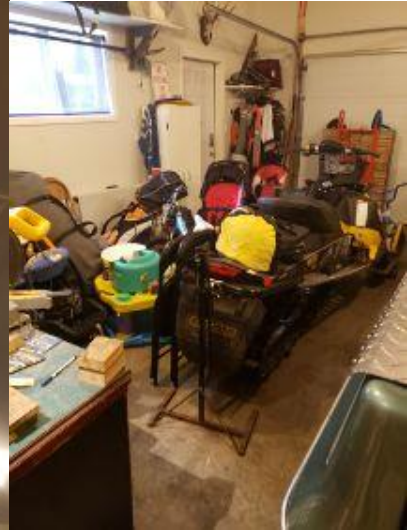
2.1 Garage (Detached)

- Recommend having a fire extinguisher installed beside the door in case of fire in garage & checked yearly.
- Automatic garage door opener. Laser sensor working.
- Furnace working using normal operating controls. No anomalies noticed on the thermal camera. Fittings tested for leaks, nothing observed.
- Did not inspect attic due to valuables/personal items possibly getting scratched with the ladder

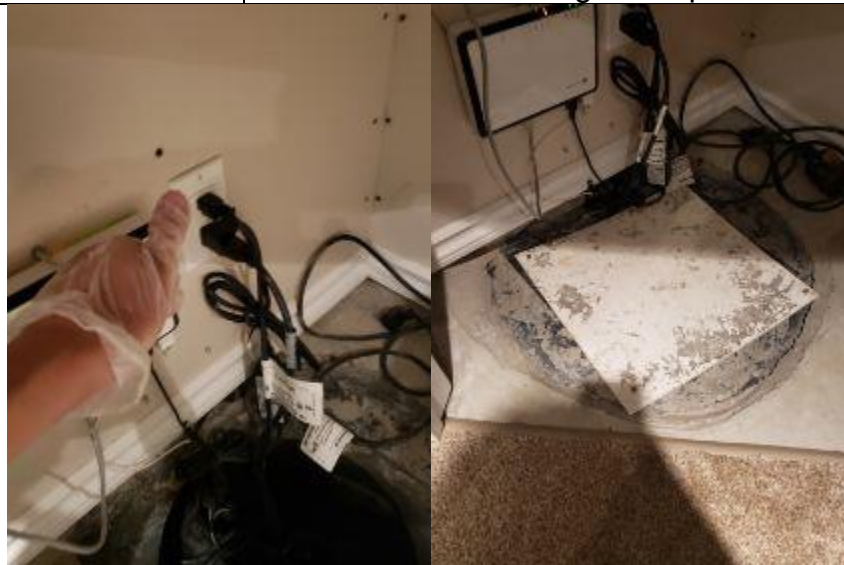
2.2 Basement/Crawlspace

- Poured concrete in visible area
- Sump pump tested and working with direct plug in and raising the float.
- Recommend installing a sump alarm

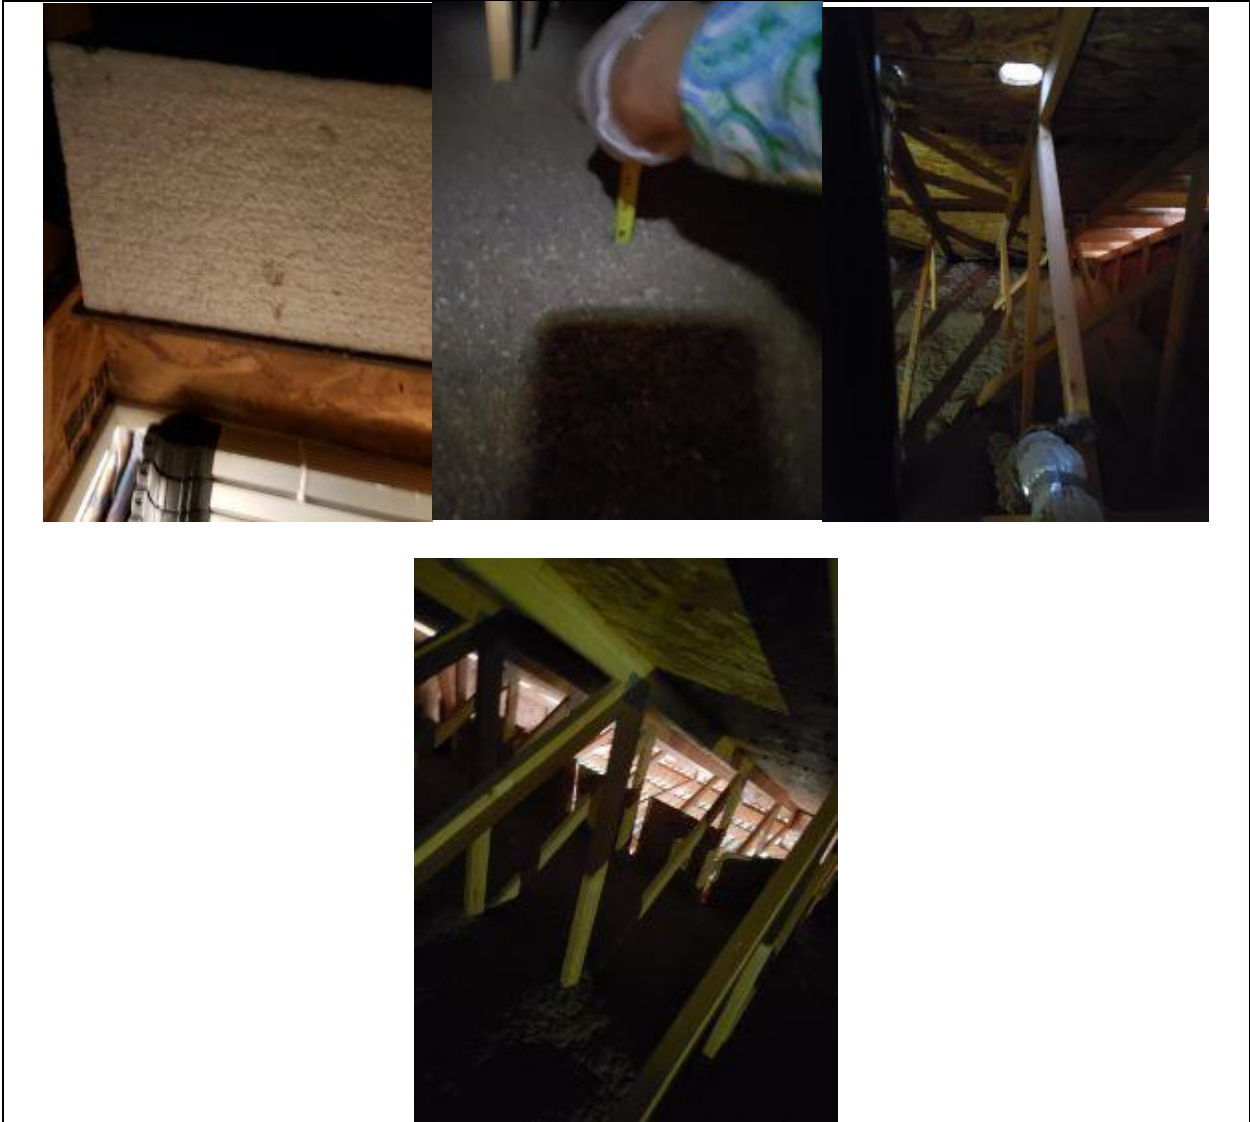
2.3 Attic

- Blown in cellulose insulation observed. About 9" in main house attic.
- Venting observed into attic space. Recommend this go through a roof vent to prevent moisture problems in the attic. The duct to the vent appears to have just fallen out
- Active roof leaks not observed.
- Uninsulated soffit venting is over the main porch area.

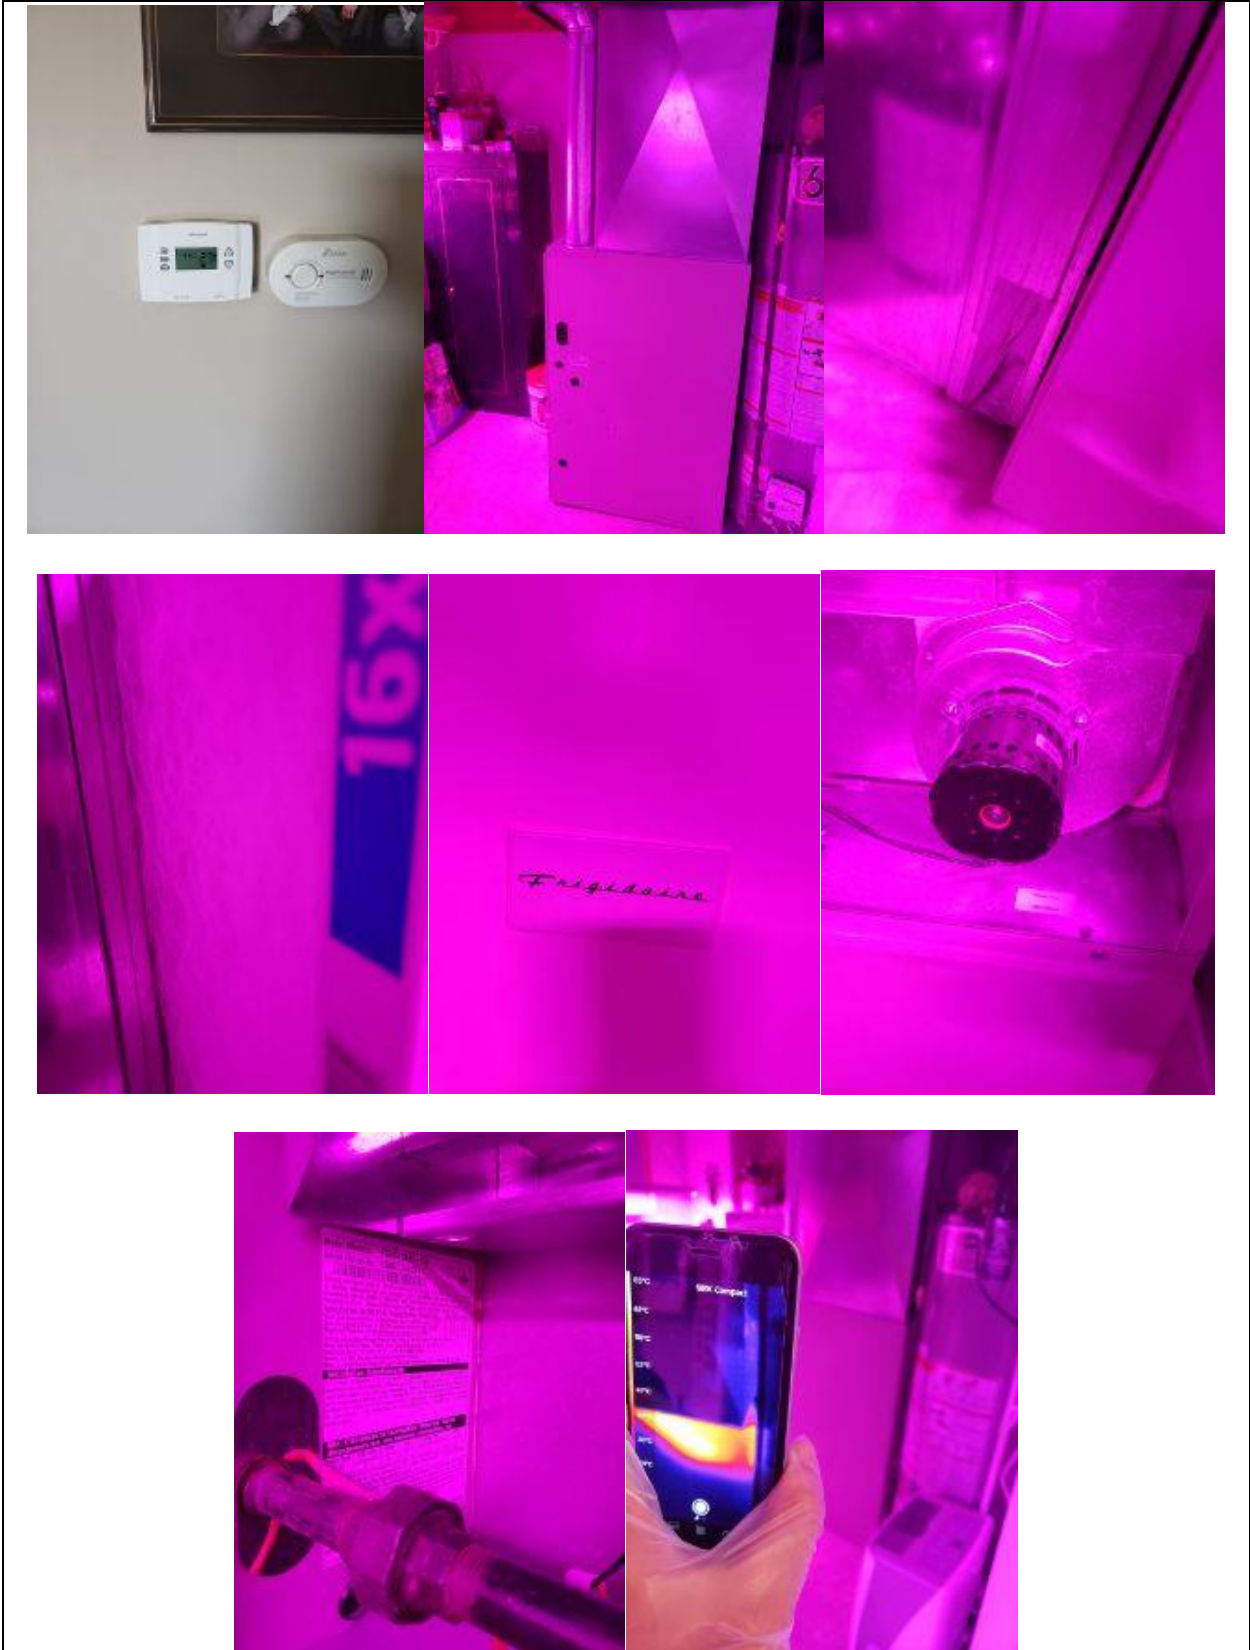
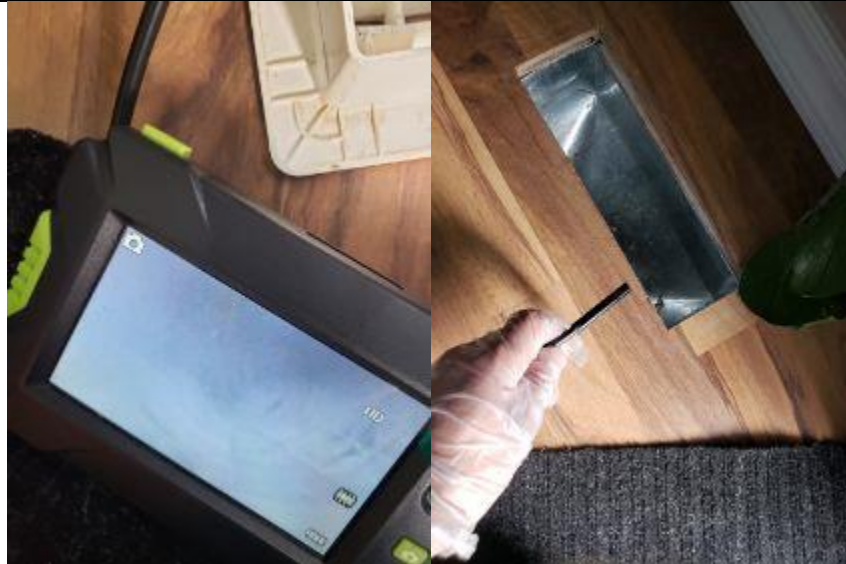
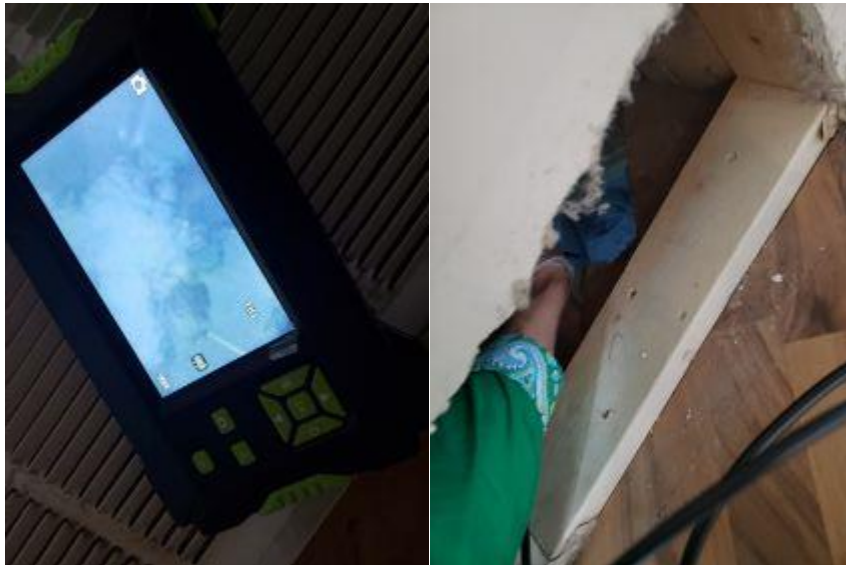
3.2 HVAC System

Observations	<ul style="list-style-type: none"> • Mid efficiency furnace (up to ~80% AFUE) • Frigidaire (2007) 	<ul style="list-style-type: none"> • Suspected crack in the furnace heat exchanger. Recommend consulting a qualified HVAC technician to confirm and replace if required. Insulated sidewall was very hot to the touch. • Change furnace filter as directed by manufacturer (typically 3-6 months) • Gas fittings were leak tested. Nothing observed. No active or previous condensation was observed in the furnace. • Ductwork checked for dust. Would not recommend duct cleaning at this time, typically, every 5 years.
--------------	---	---

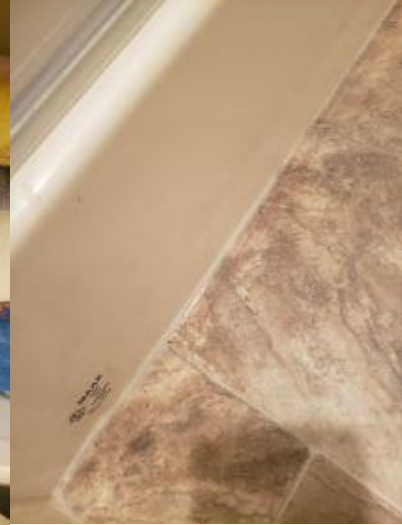
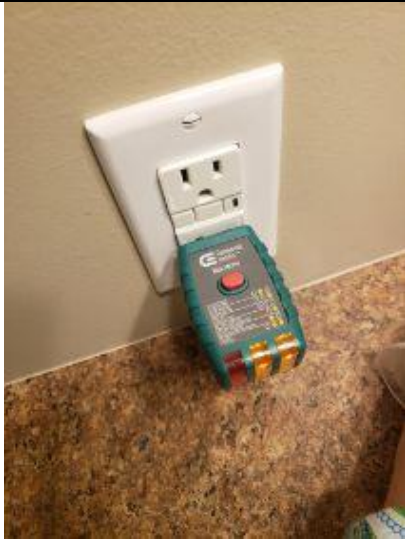
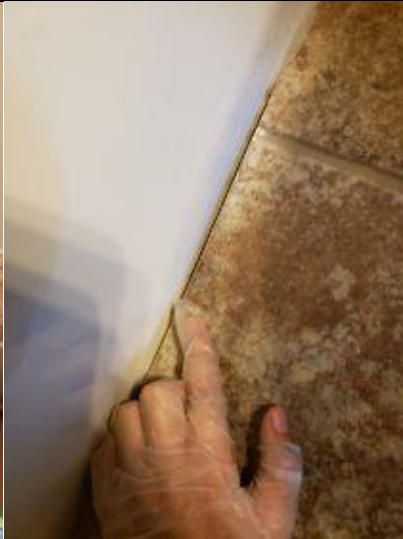
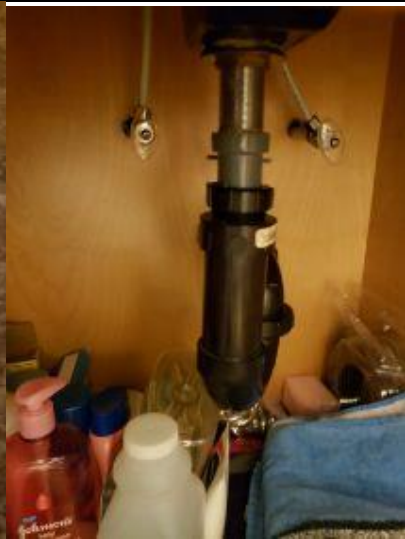
4.2 Bathrooms

- All bathroom vents had sufficient suction to hold a piece of paper against the guard.
- Downstairs toilet was loose recommend retightening, some missing caulking around the bases
- Showers, toilets and sinks all working during the inspection. No active leaks were observed.
- Flooring between the tubs in upstairs bathrooms has become loose. Recommend re-securing and recaulking
- No active leaks observed.

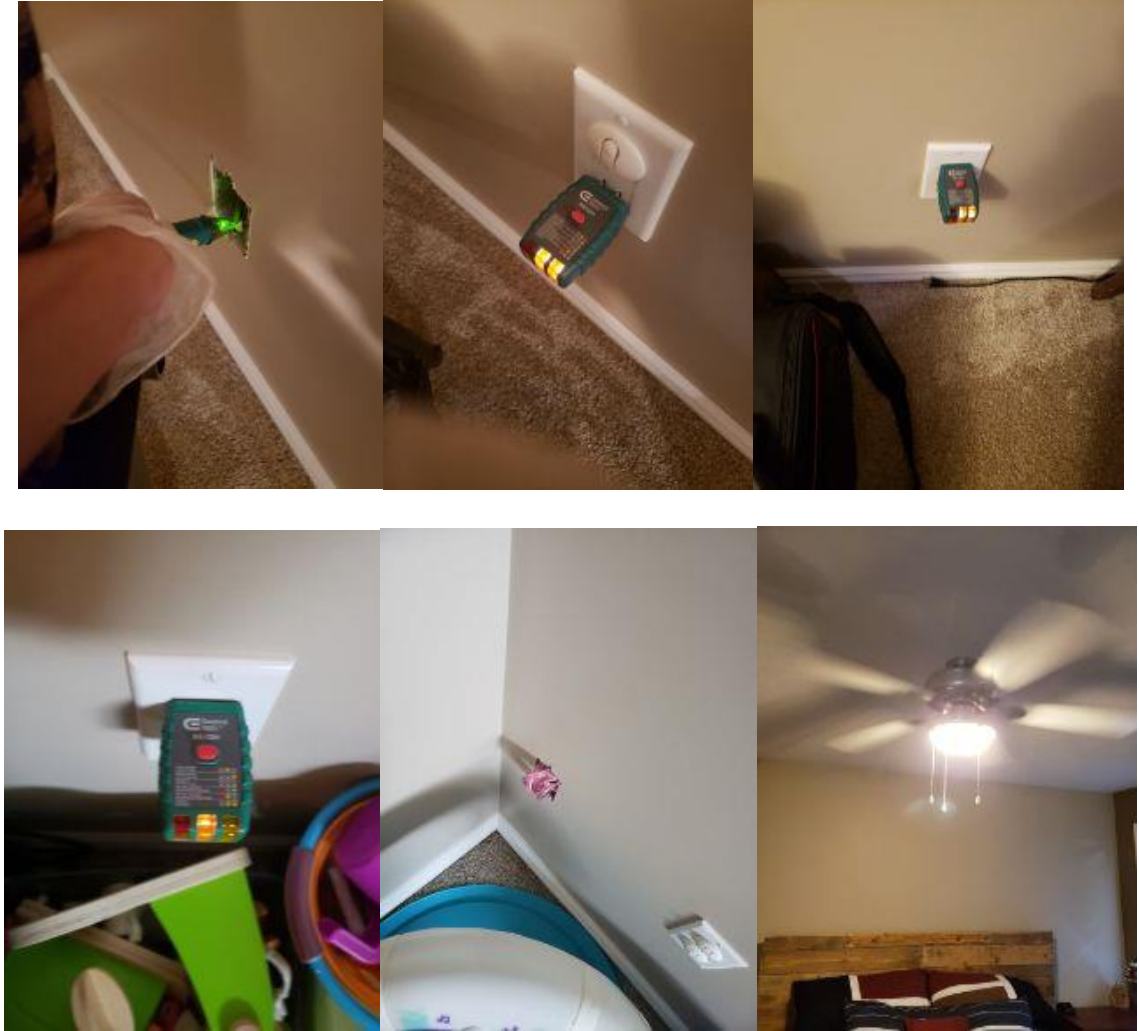
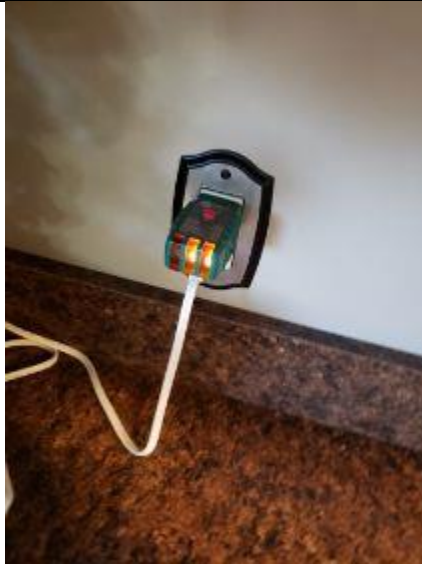
4.3 Interior Electric

Observations	<ul style="list-style-type: none">• Tested all visible outlets, could not confirm ground working on one outlet in the basement. Likely just a loose wire, contact a qualified electrician.• Recommend covering any exposed wires or electrical boxes.

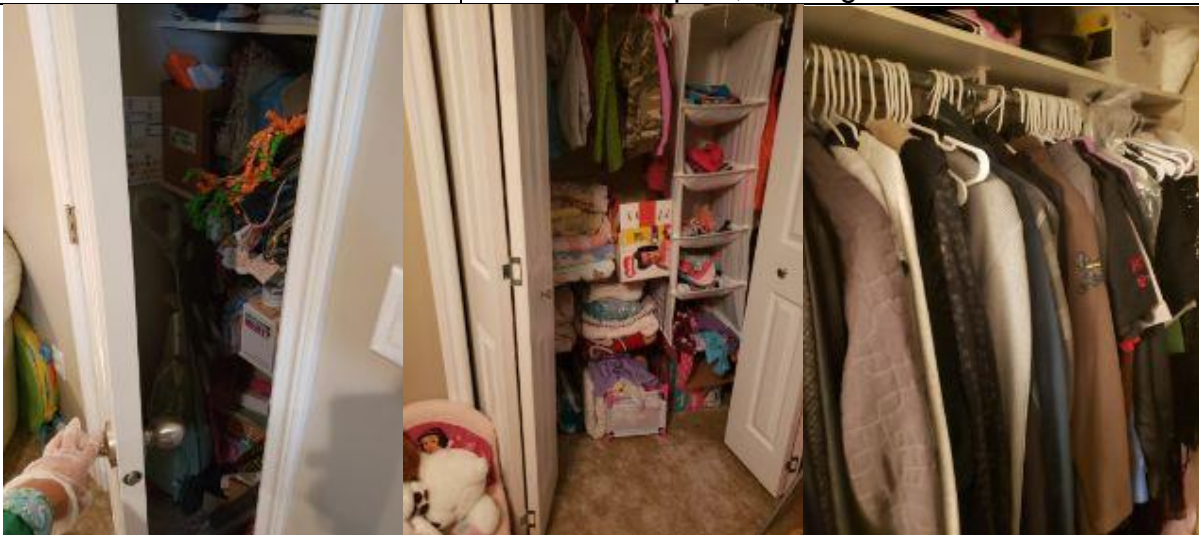
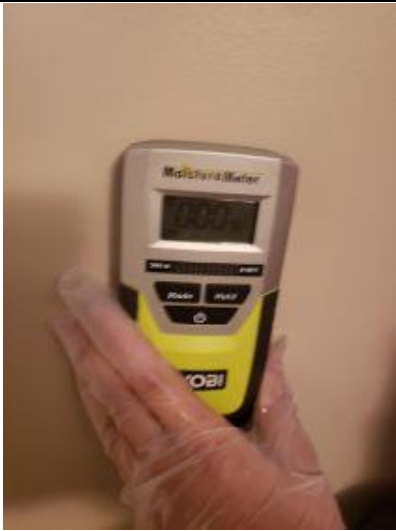
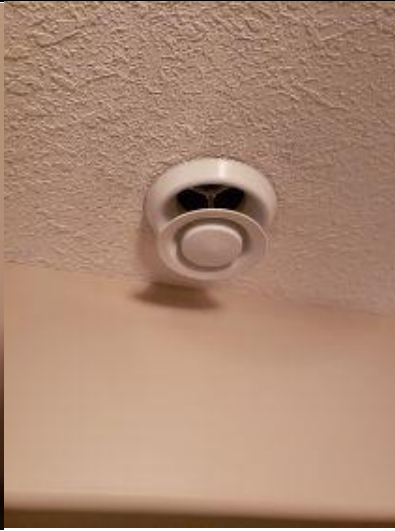
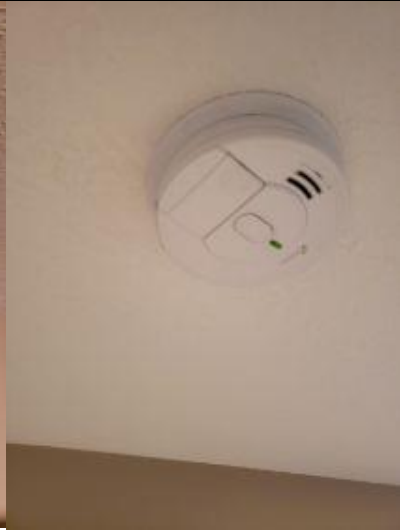
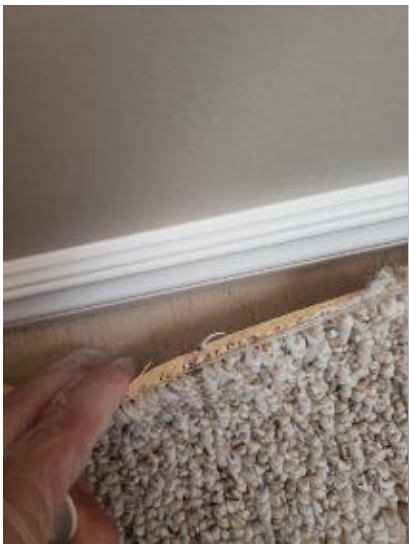
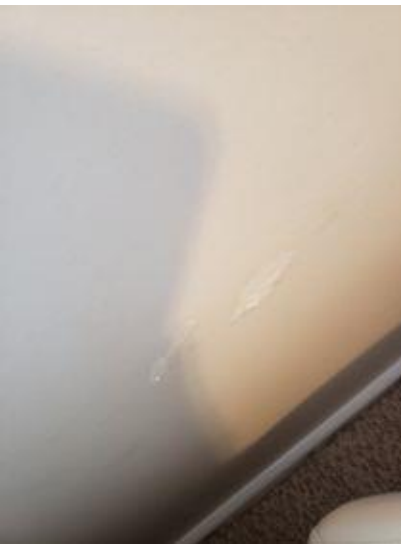
4.4 Floors, Ceilings and Walls

- No major system safety or function concerns noted at time of inspection.
- Not every area of the house was able to be inspected due to personal items (closets, etc.)
- One small ceiling crack noticed on the ridge between the kitchen and living space
- One carpet area in the upstairs bedroom did not extend to the wall, repair marks on wall observed.
- Some of the upstairs flooring was a bit creaky, possibly from very warm weather and thermal expansion. Creaks can be fixed with graphite powder.
- Moisture meter was used in the basement to try to find wet wall spots, nothing observed.

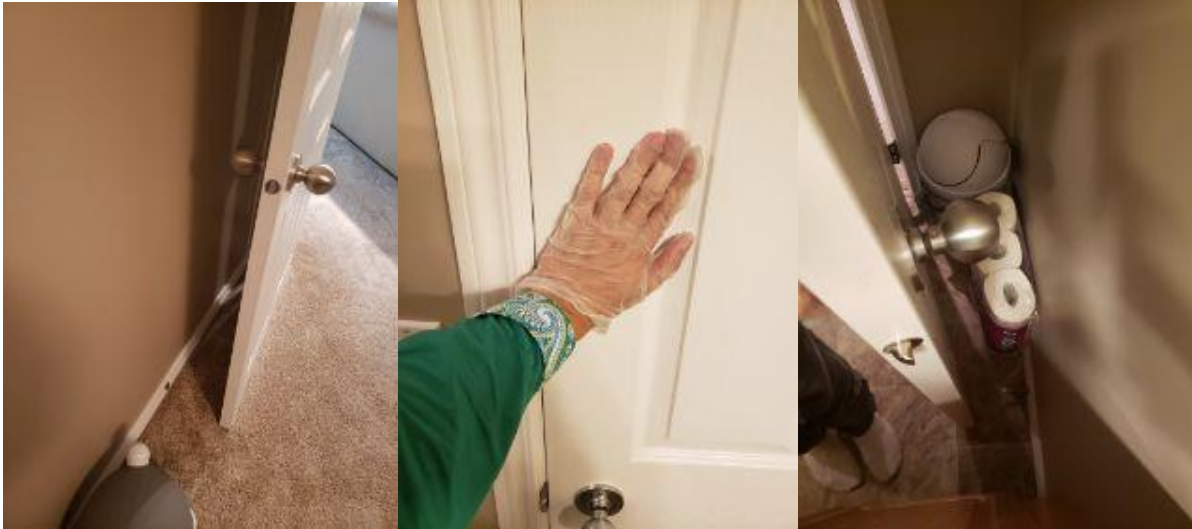
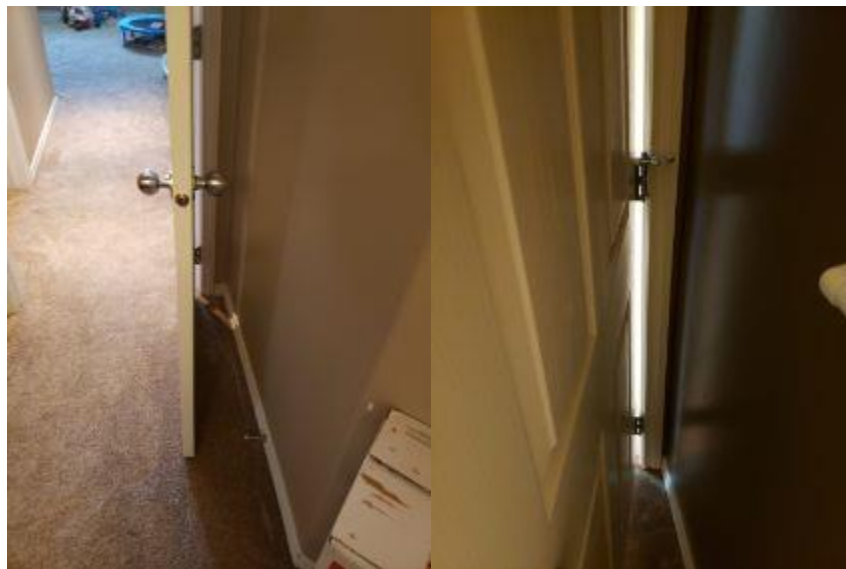
4.5 Doors

Observations	<ul style="list-style-type: none"> • One missing doorstop noticed downstairs. • Had to do some adjusting to get the downstairs bathroom door to close. Recommend adjusting.
--------------	---

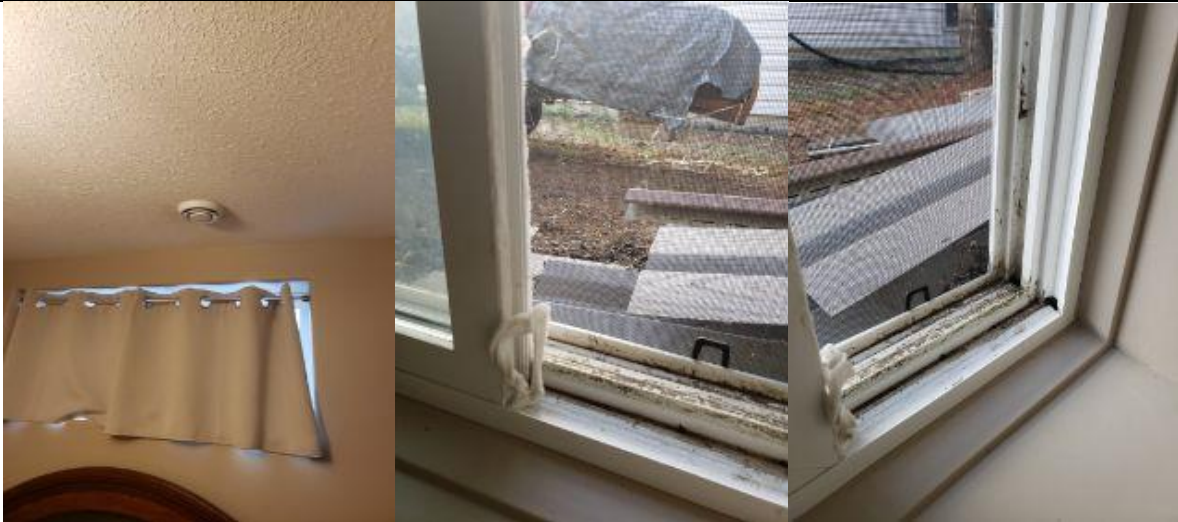
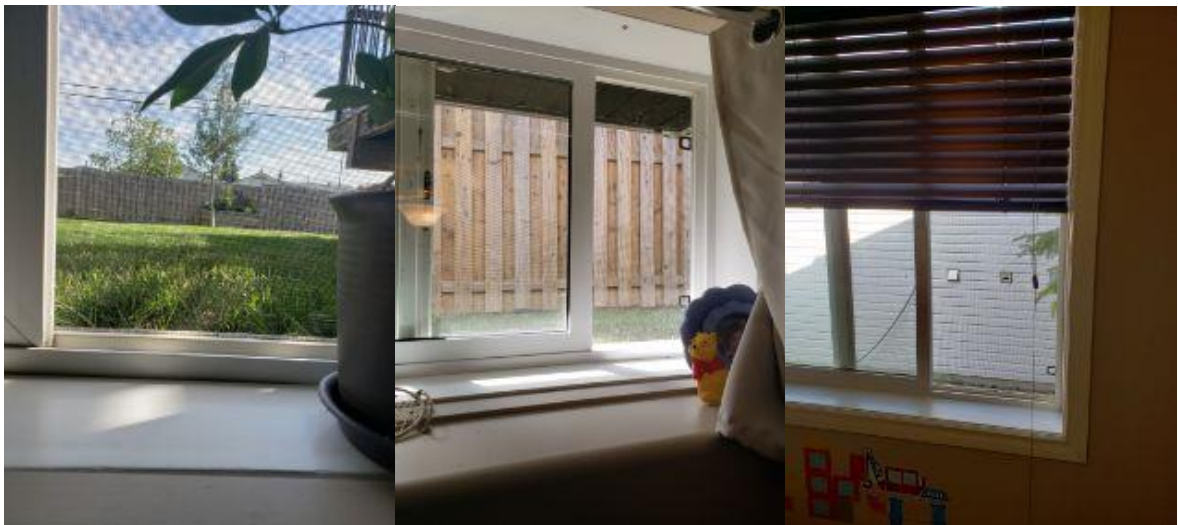
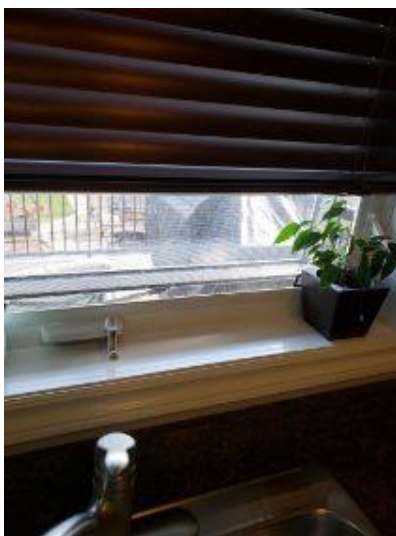
4.6 Windows	
Observations	<ul style="list-style-type: none"> • All windows and blinds were operating and able to adjust. • Weather stripping on one basement window was damaged
