Gambit Inspections Ltd.

Your property inspection report

90210 Electric Ave

Inspection prepared for: John & Jane Doe

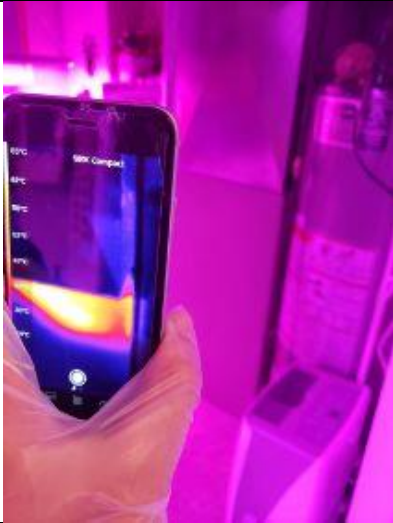
3. Electrical, HVAC, Water Heater & Laundry Appliances		
3.2	HVAC	<ul style="list-style-type: none">• Suspected crack in the furnace heat exchanger. Recommend consulting a qualified HVAC technician to confirm and replace if required. Insulated sidewall was very hot to the touch.

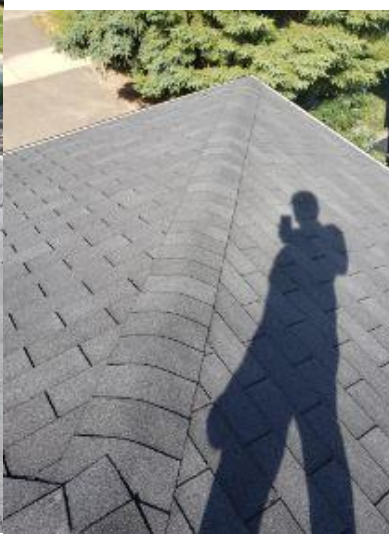
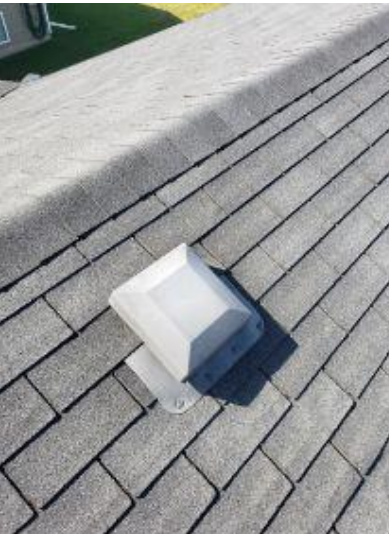
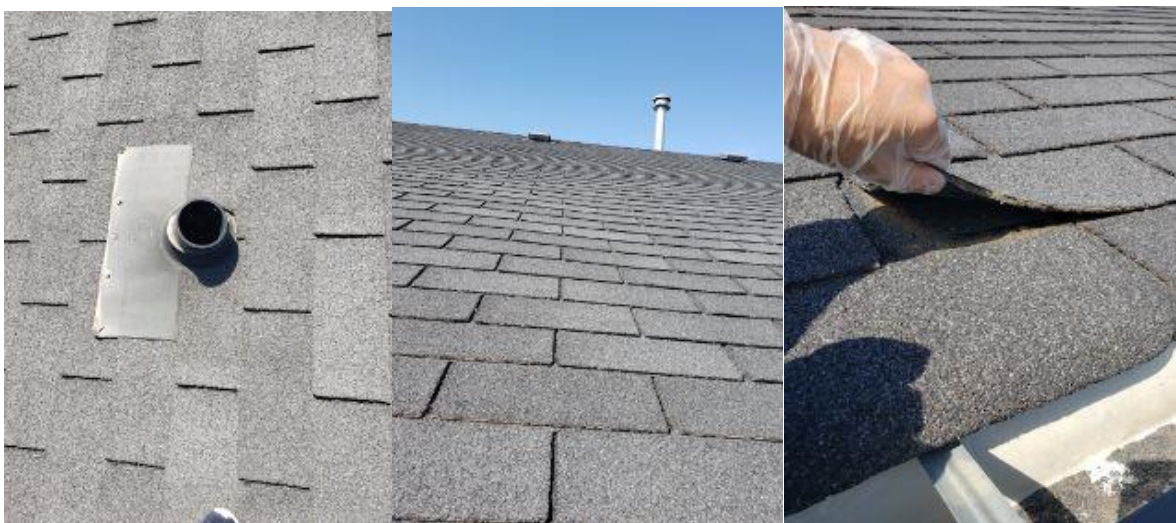
1.1 Roof

Materials	3-Tab asphalt shingles, life expectancy 20 years from installation with proper maintenance.	<ul style="list-style-type: none">• No major system safety or function concerns noted at time of inspection. Normal aged.• Flashings installed, no loose nails observed during inspection. Would recommend adding roofing tar to nails that are exposed.• Some loose shingles noticed but no excessive cupping or curling was observed.
-----------	---	---

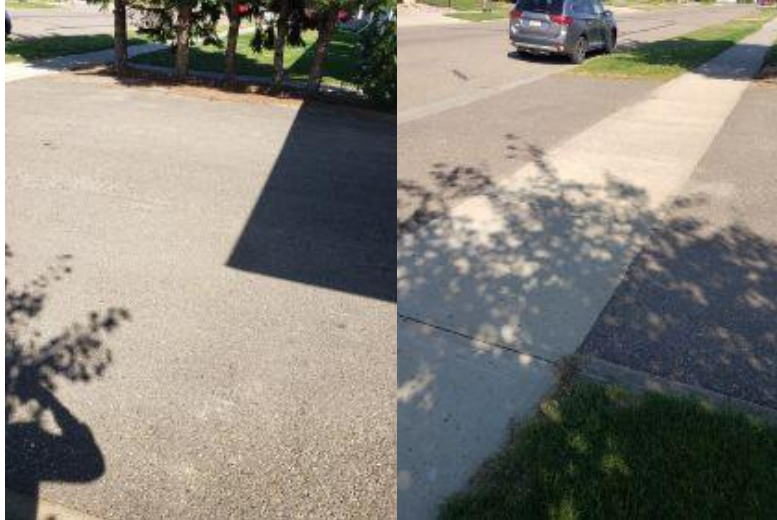
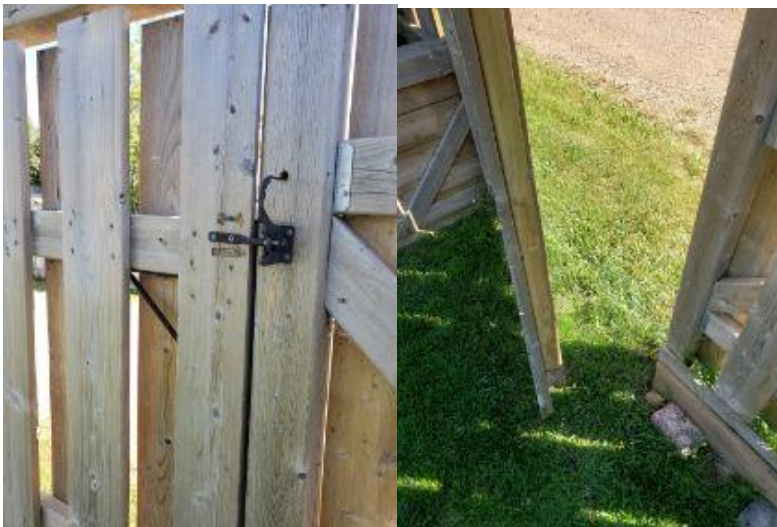
1.3 Drives and Walks

Observations	<ul style="list-style-type: none"> • No major system safety or function concerns noted at time of inspection.
--------------	--

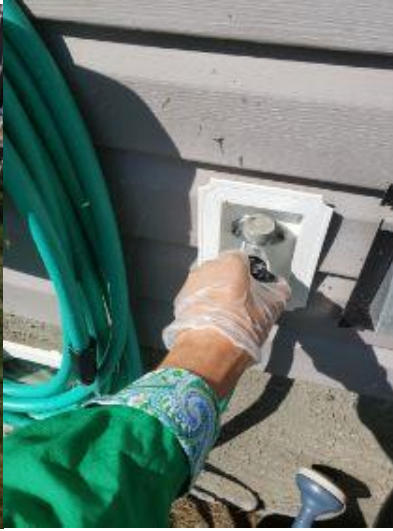
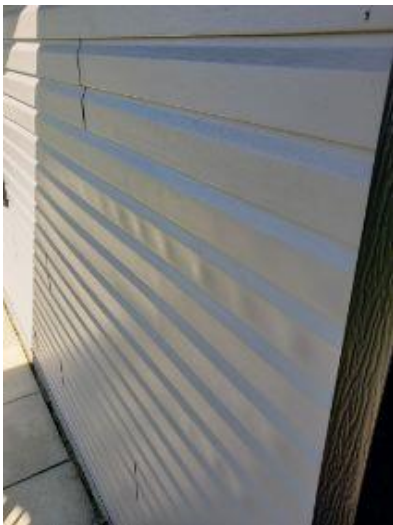
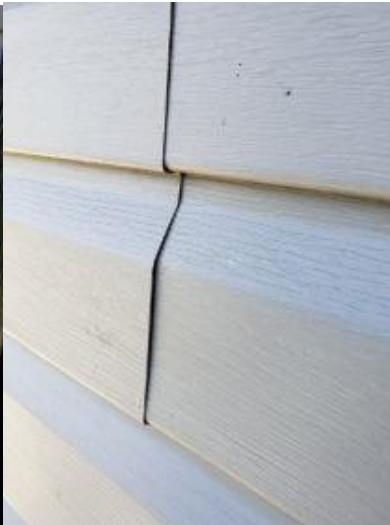
1.4 Facade

Materials	Vinyl, wood frame construction, concrete foundation	<ul style="list-style-type: none"> • No major system safety or function concerns noted at time of inspection. • Clean furnace + dryer air intake cover yearly. • Recommend caulking and sealing all gaps, cracks and openings. • Maintenance tip: addressing parging on foundation wall every 4-5 years recommended to prevent water intrusion in foundation cracks
-----------	---	---

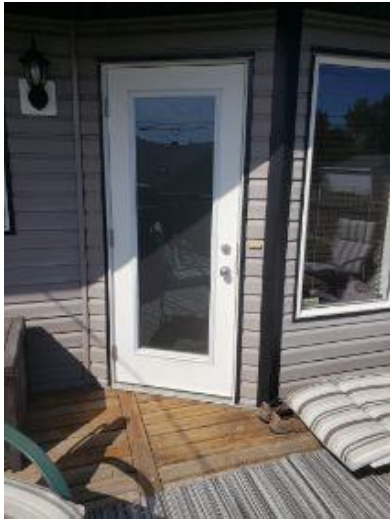
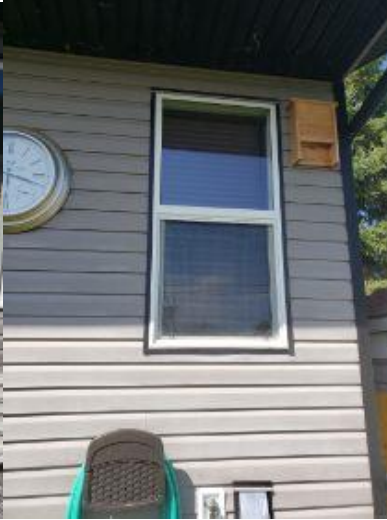
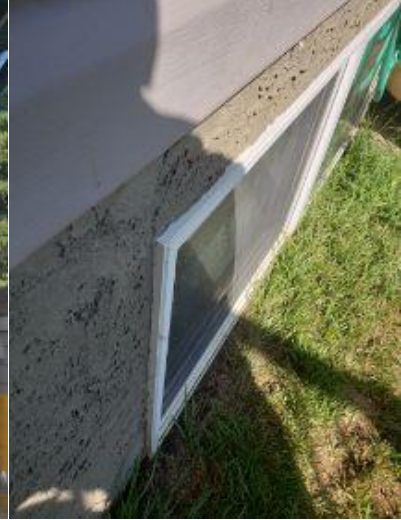
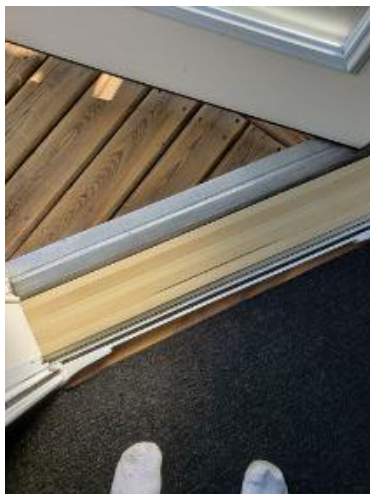
1.8 Doors and Windows

- Flashings not observed on basement windows to prevent water entry, would recommend using urethane or silicone to prevent moisture intrusion
- Exterior doors opened & closed smoothly
- Back deck door observed some air leakage on the thermal camera. Weather stripping was a bit worn.
- 2 exterior windows were very close to grade. Would recommend window wells be installed to prevent water entry.

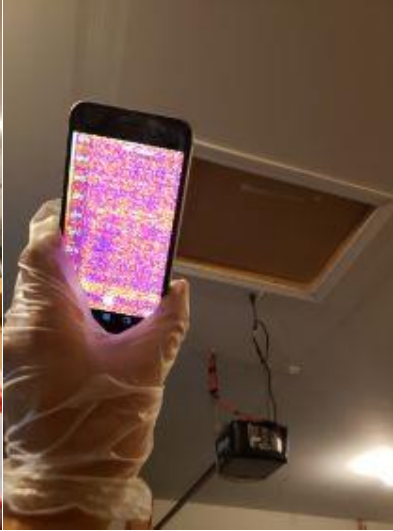
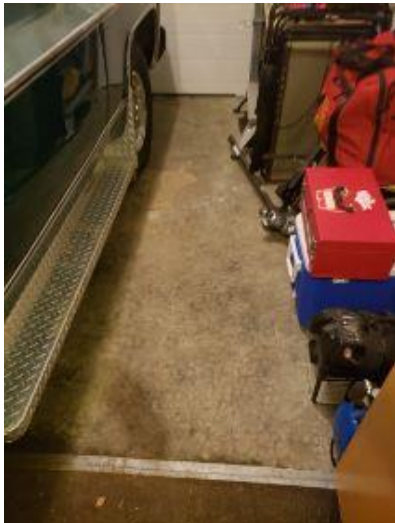
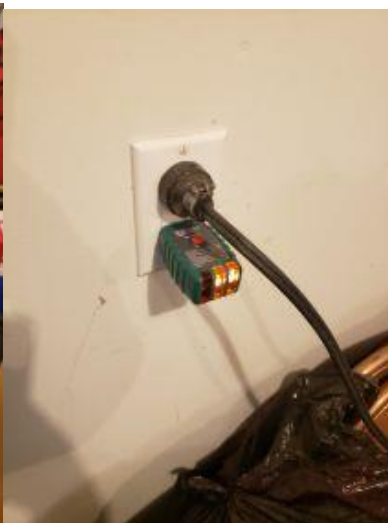
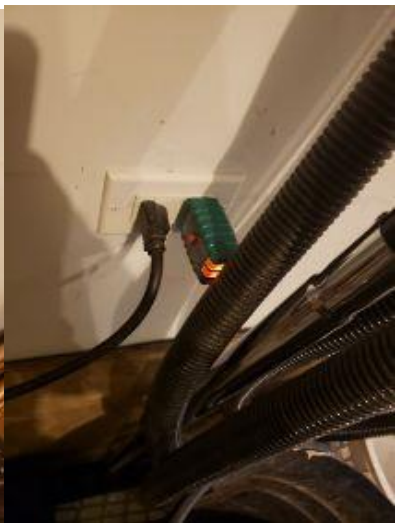
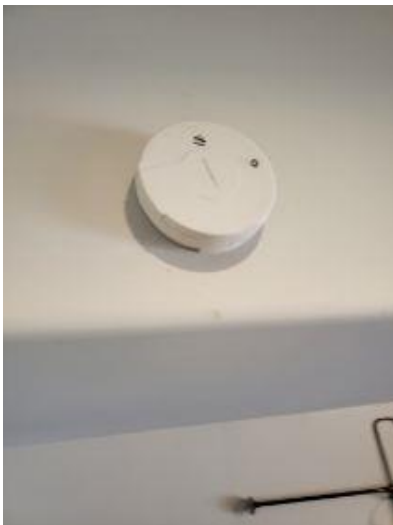
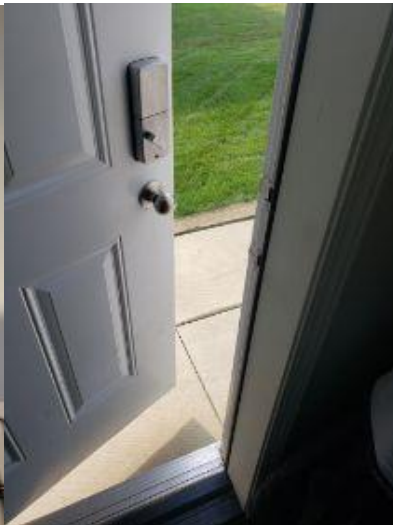
2.1 Garage (Detached)

- Recommend having a fire extinguisher installed beside the door in case of fire in garage & checked yearly.
- Automatic garage door opener. Laser sensor working.
- Furnace working using normal operating controls. No anomalies noticed on the thermal camera. Fittings tested for leaks, nothing observed.
- Did not inspect attic due to valuables/personal items possibly getting scratched with the ladder

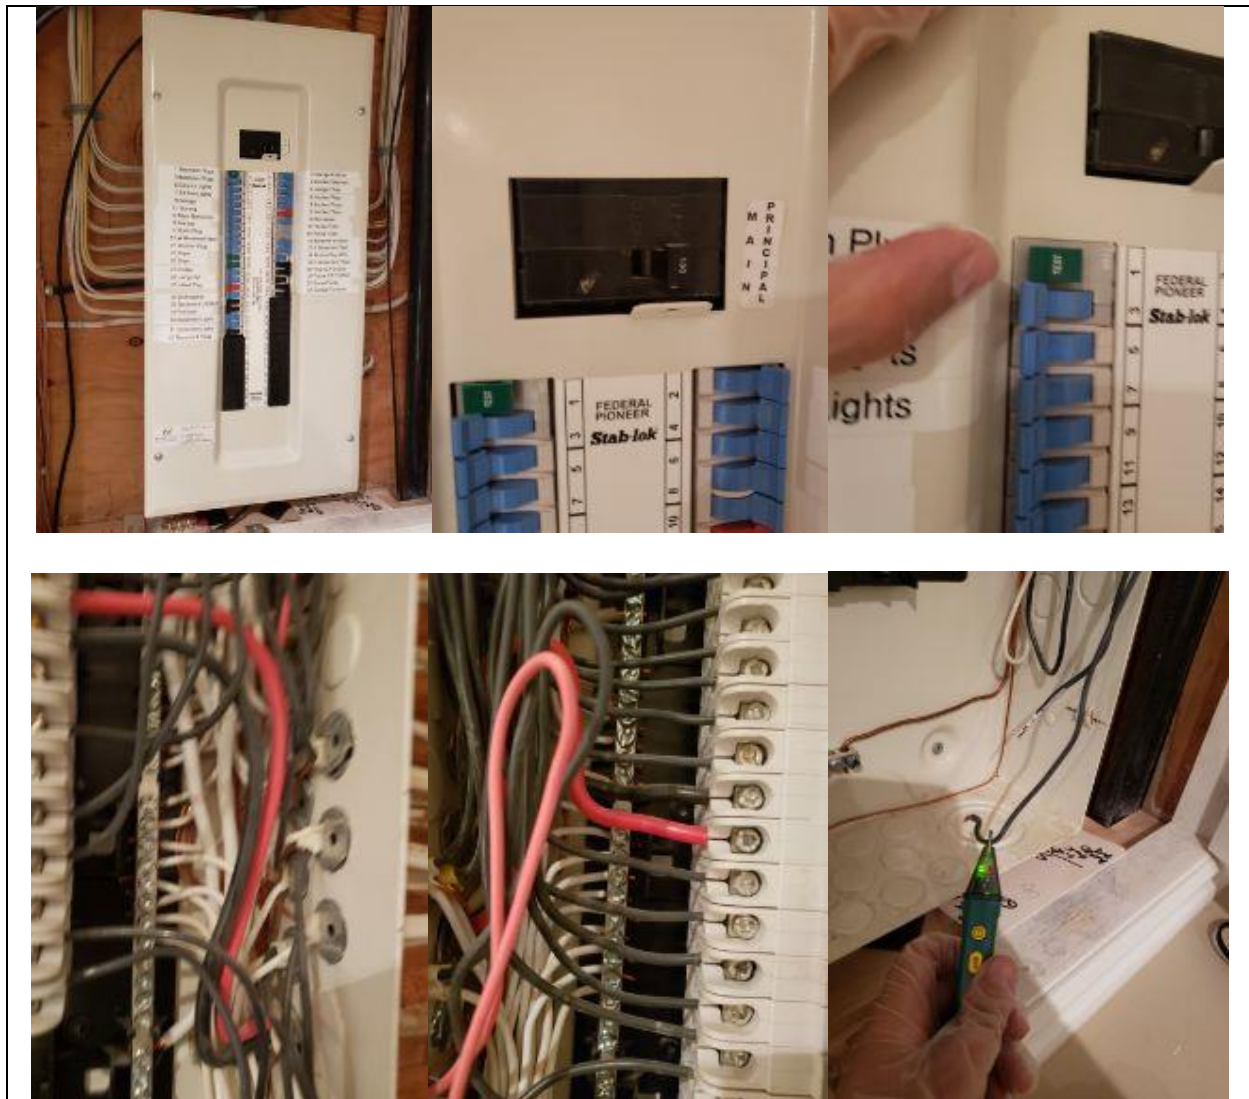
3 Electric, Heat, Water Heater & Laundry Appliances		
3.1 Electrical Panel		
Observations	Copper wiring 100A Breaker	<ul style="list-style-type: none"> • No major system safety or function concerns noted at time of inspection. Normal aged. • Legend clearly labeled • No abnormalities observed on thermal camera

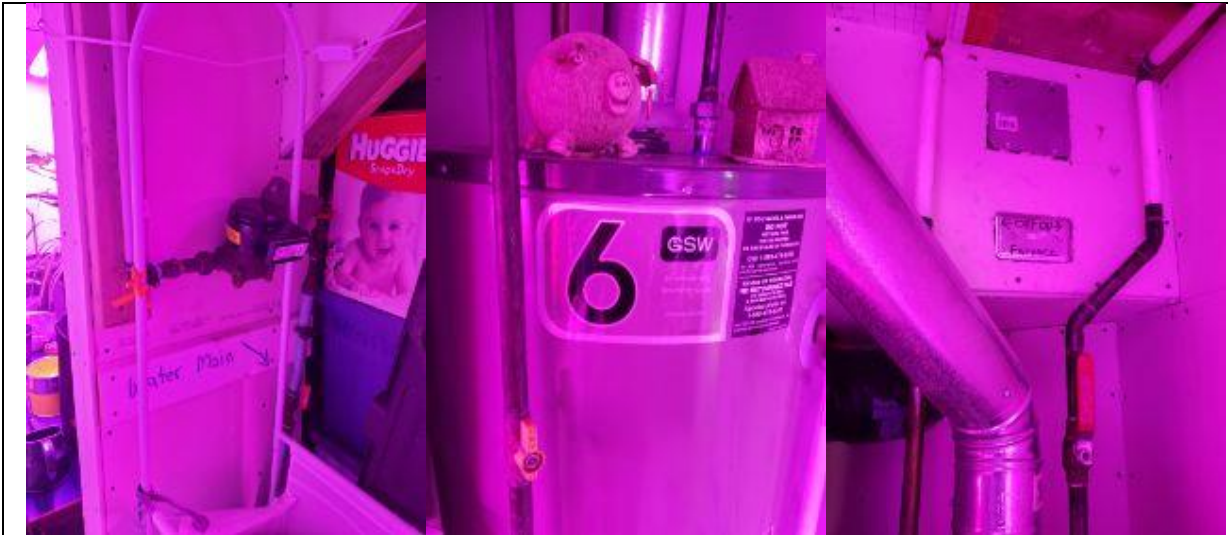
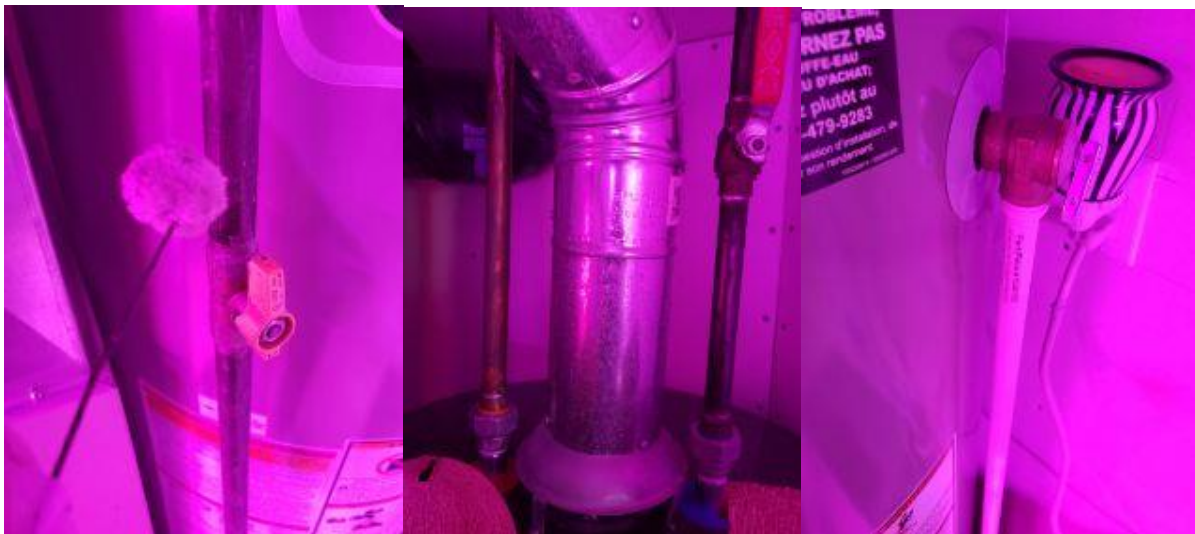
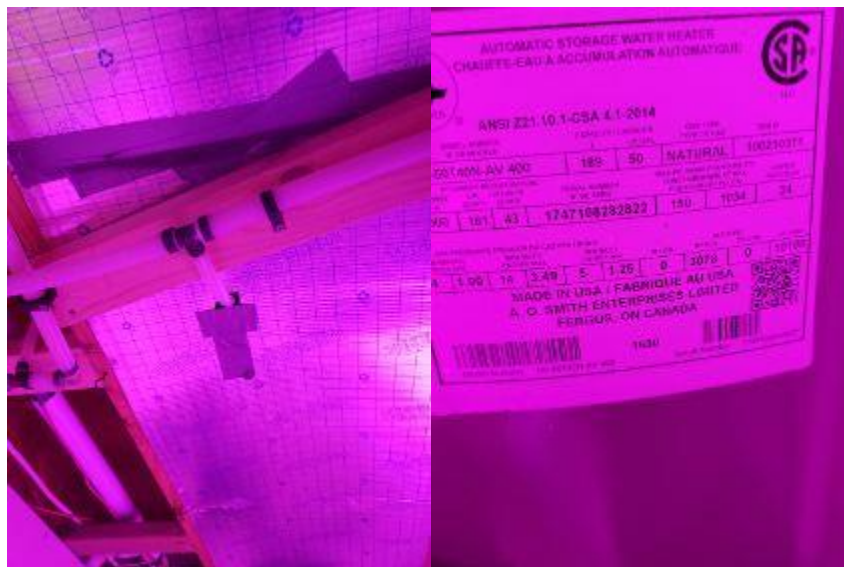
3.3 Water Heater

Observations	<p>Piping: Copper + PEX</p> <p>Gas Heated, 50 Gallon tank</p> <p>A.O. Smith (2017)</p>	<ul style="list-style-type: none"> • No major system safety or function concerns noted at time of inspection. Gas fittings were leak tested. Nothing observed. • Life expectancy about 15 year for water tanks • Water shutoff beside stairs in case of a leak, public supply
--------------	--	--

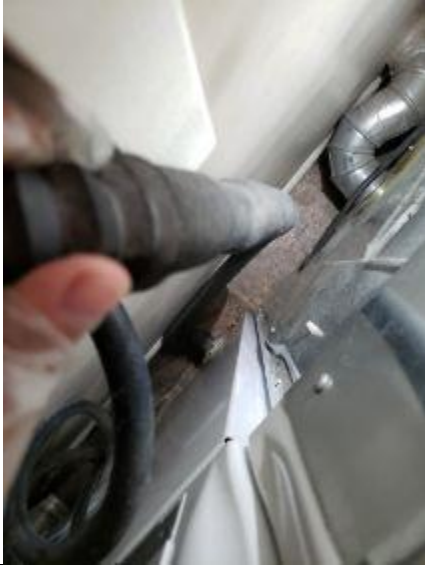
3.4 Laundry Appliances	
Observations	<ul style="list-style-type: none">• No major system safety or function concerns noted at time of inspection. Washer and dryer both worked using normal controls. No leaks behind or below washer unit observed.

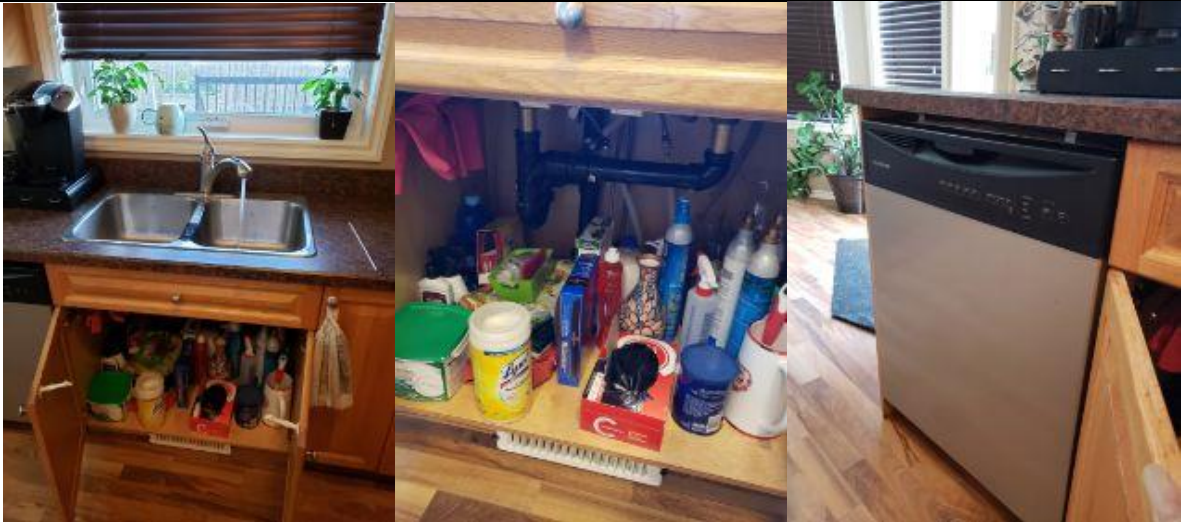
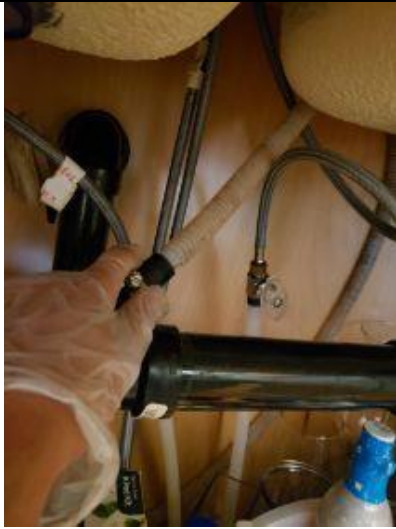
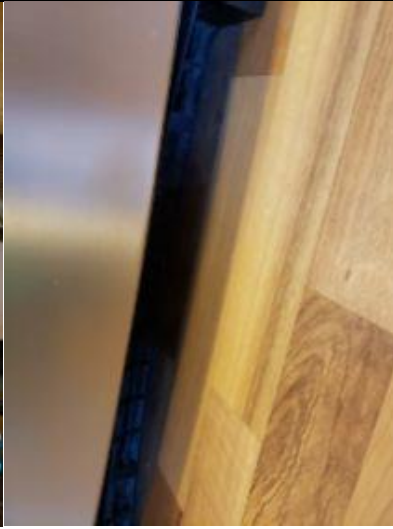
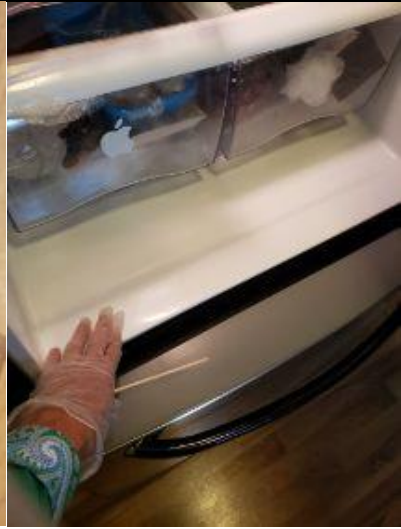
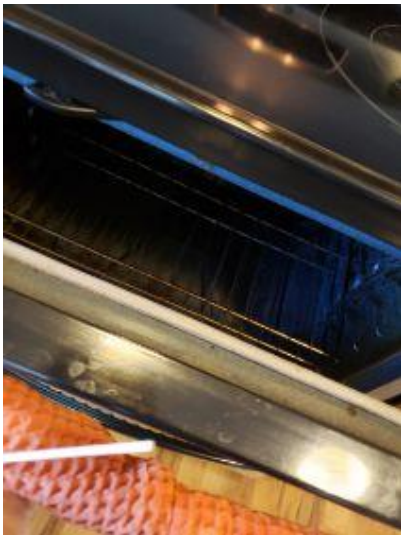
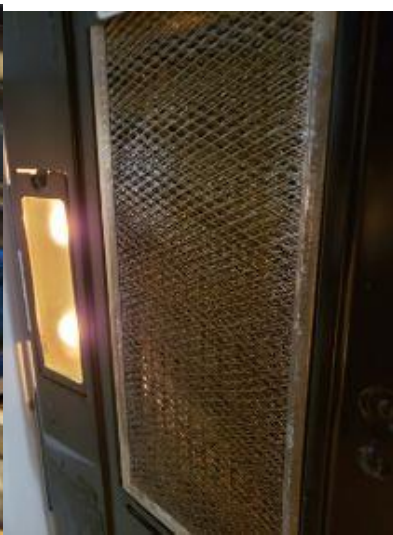
4. Interior	
4.1 Kitchen	
Observations	<ul style="list-style-type: none">• No major system safety or function concerns noted at time of inspection.• Dishwasher, stove, range, microwave and refrigerator were all working at the time of inspection.• No leaks observed around or below refrigerator, or dishwasher.• Some areas could not be inspected due to personal items.

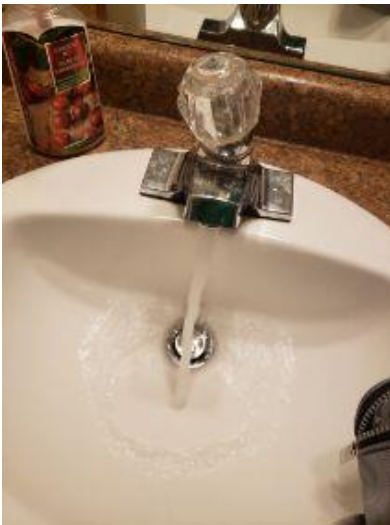
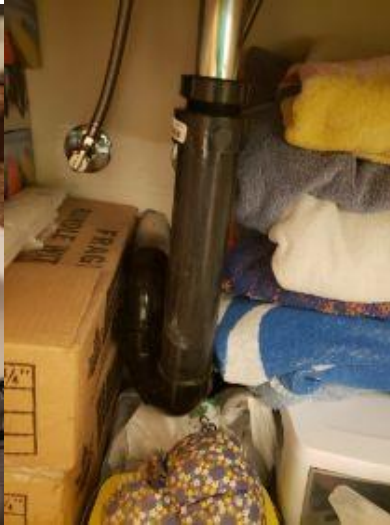
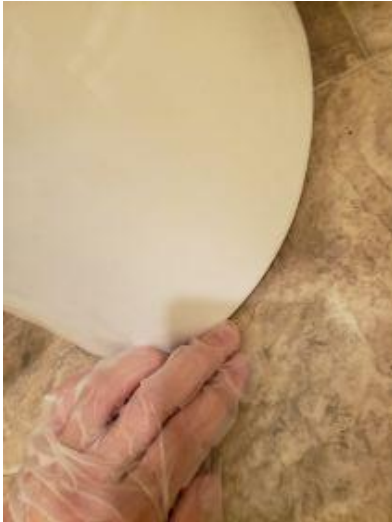
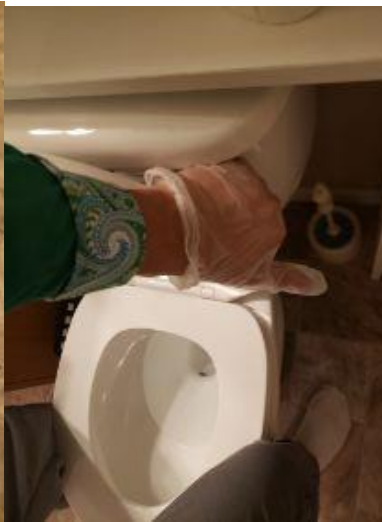
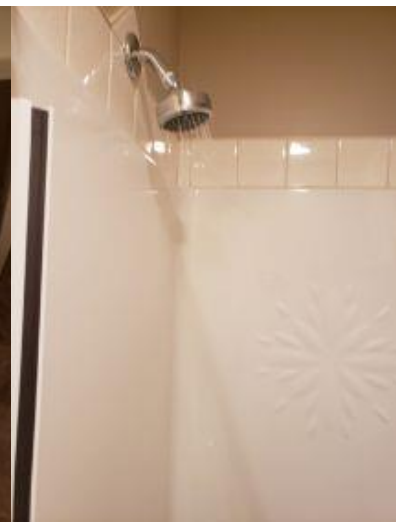
4.2 Bathrooms

- All bathroom vents had sufficient suction to hold a piece of paper against the guard.
- Downstairs toilet was loose recommend retightening, some missing caulking around the bases
- Showers, toilets and sinks all working during the inspection. No active leaks were observed.
- Flooring between the tubs in upstairs bathrooms has become loose. Recommend re-securing and recaulking
- No active leaks observed.

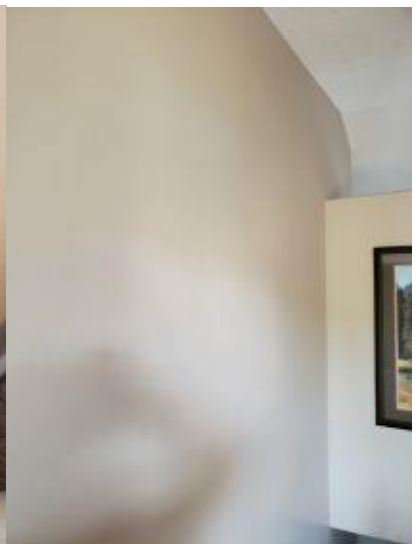
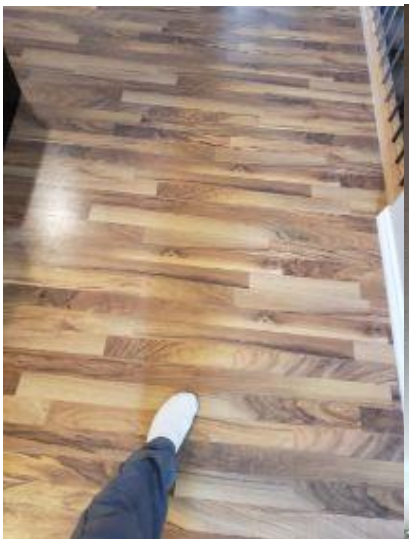
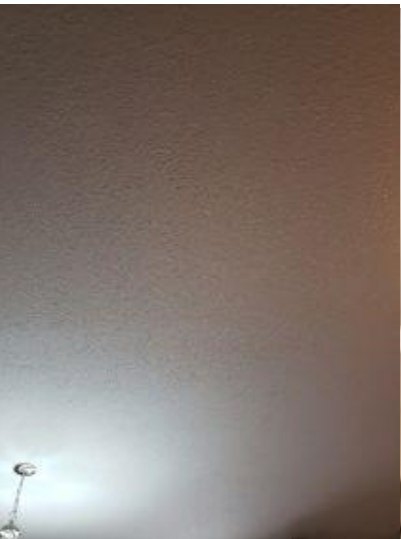
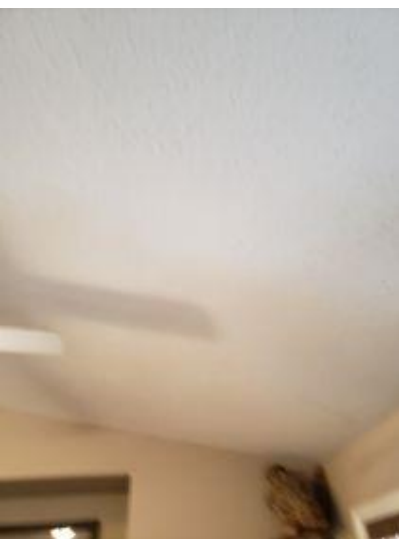
4.4 Floors, Ceilings and Walls

- No major system safety or function concerns noted at time of inspection.
- Not every area of the house was able to be inspected due to personal items (closets, etc.)
- One small ceiling crack noticed on the ridge between the kitchen and living space
- One carpet area in the upstairs bedroom did not extend to the wall, repair marks on wall observed.
- Some of the upstairs flooring was a bit creaky, possibly from very warm weather and thermal expansion. Creaks can be fixed with graphite powder.
- Moisture meter was used in the basement to try to find wet wall spots, nothing observed.

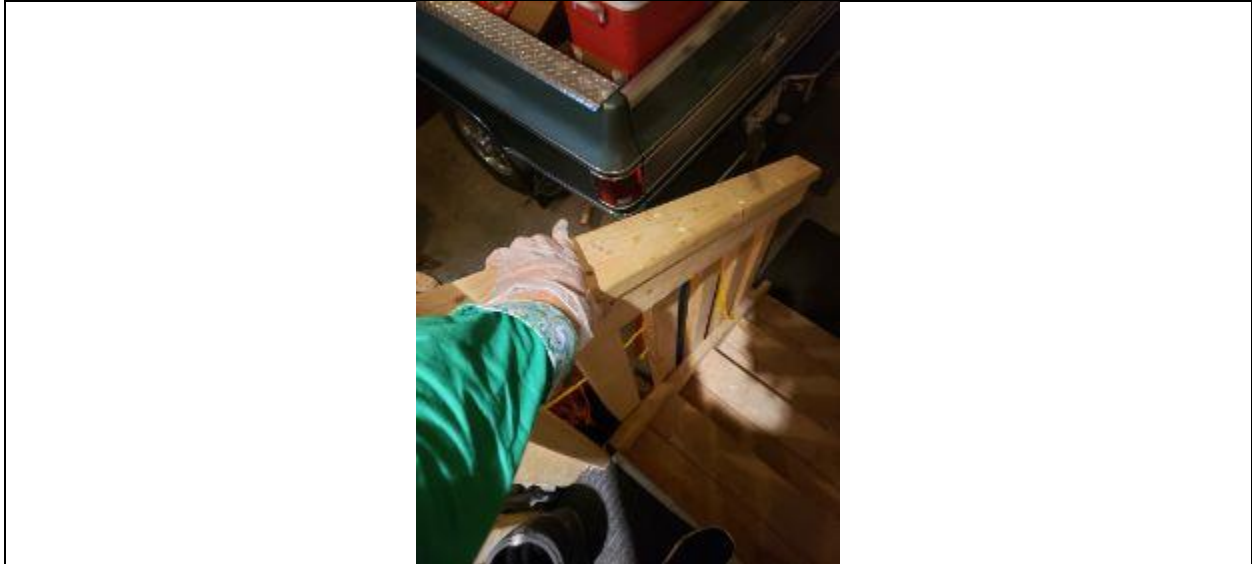
- No areas of concern
